DRAINAGE INVENTORY PRELIMINARY FINDINGS MEMO

Farming in the Floodplain Project

Prepared for
PCC Farmland Trust

November 2016

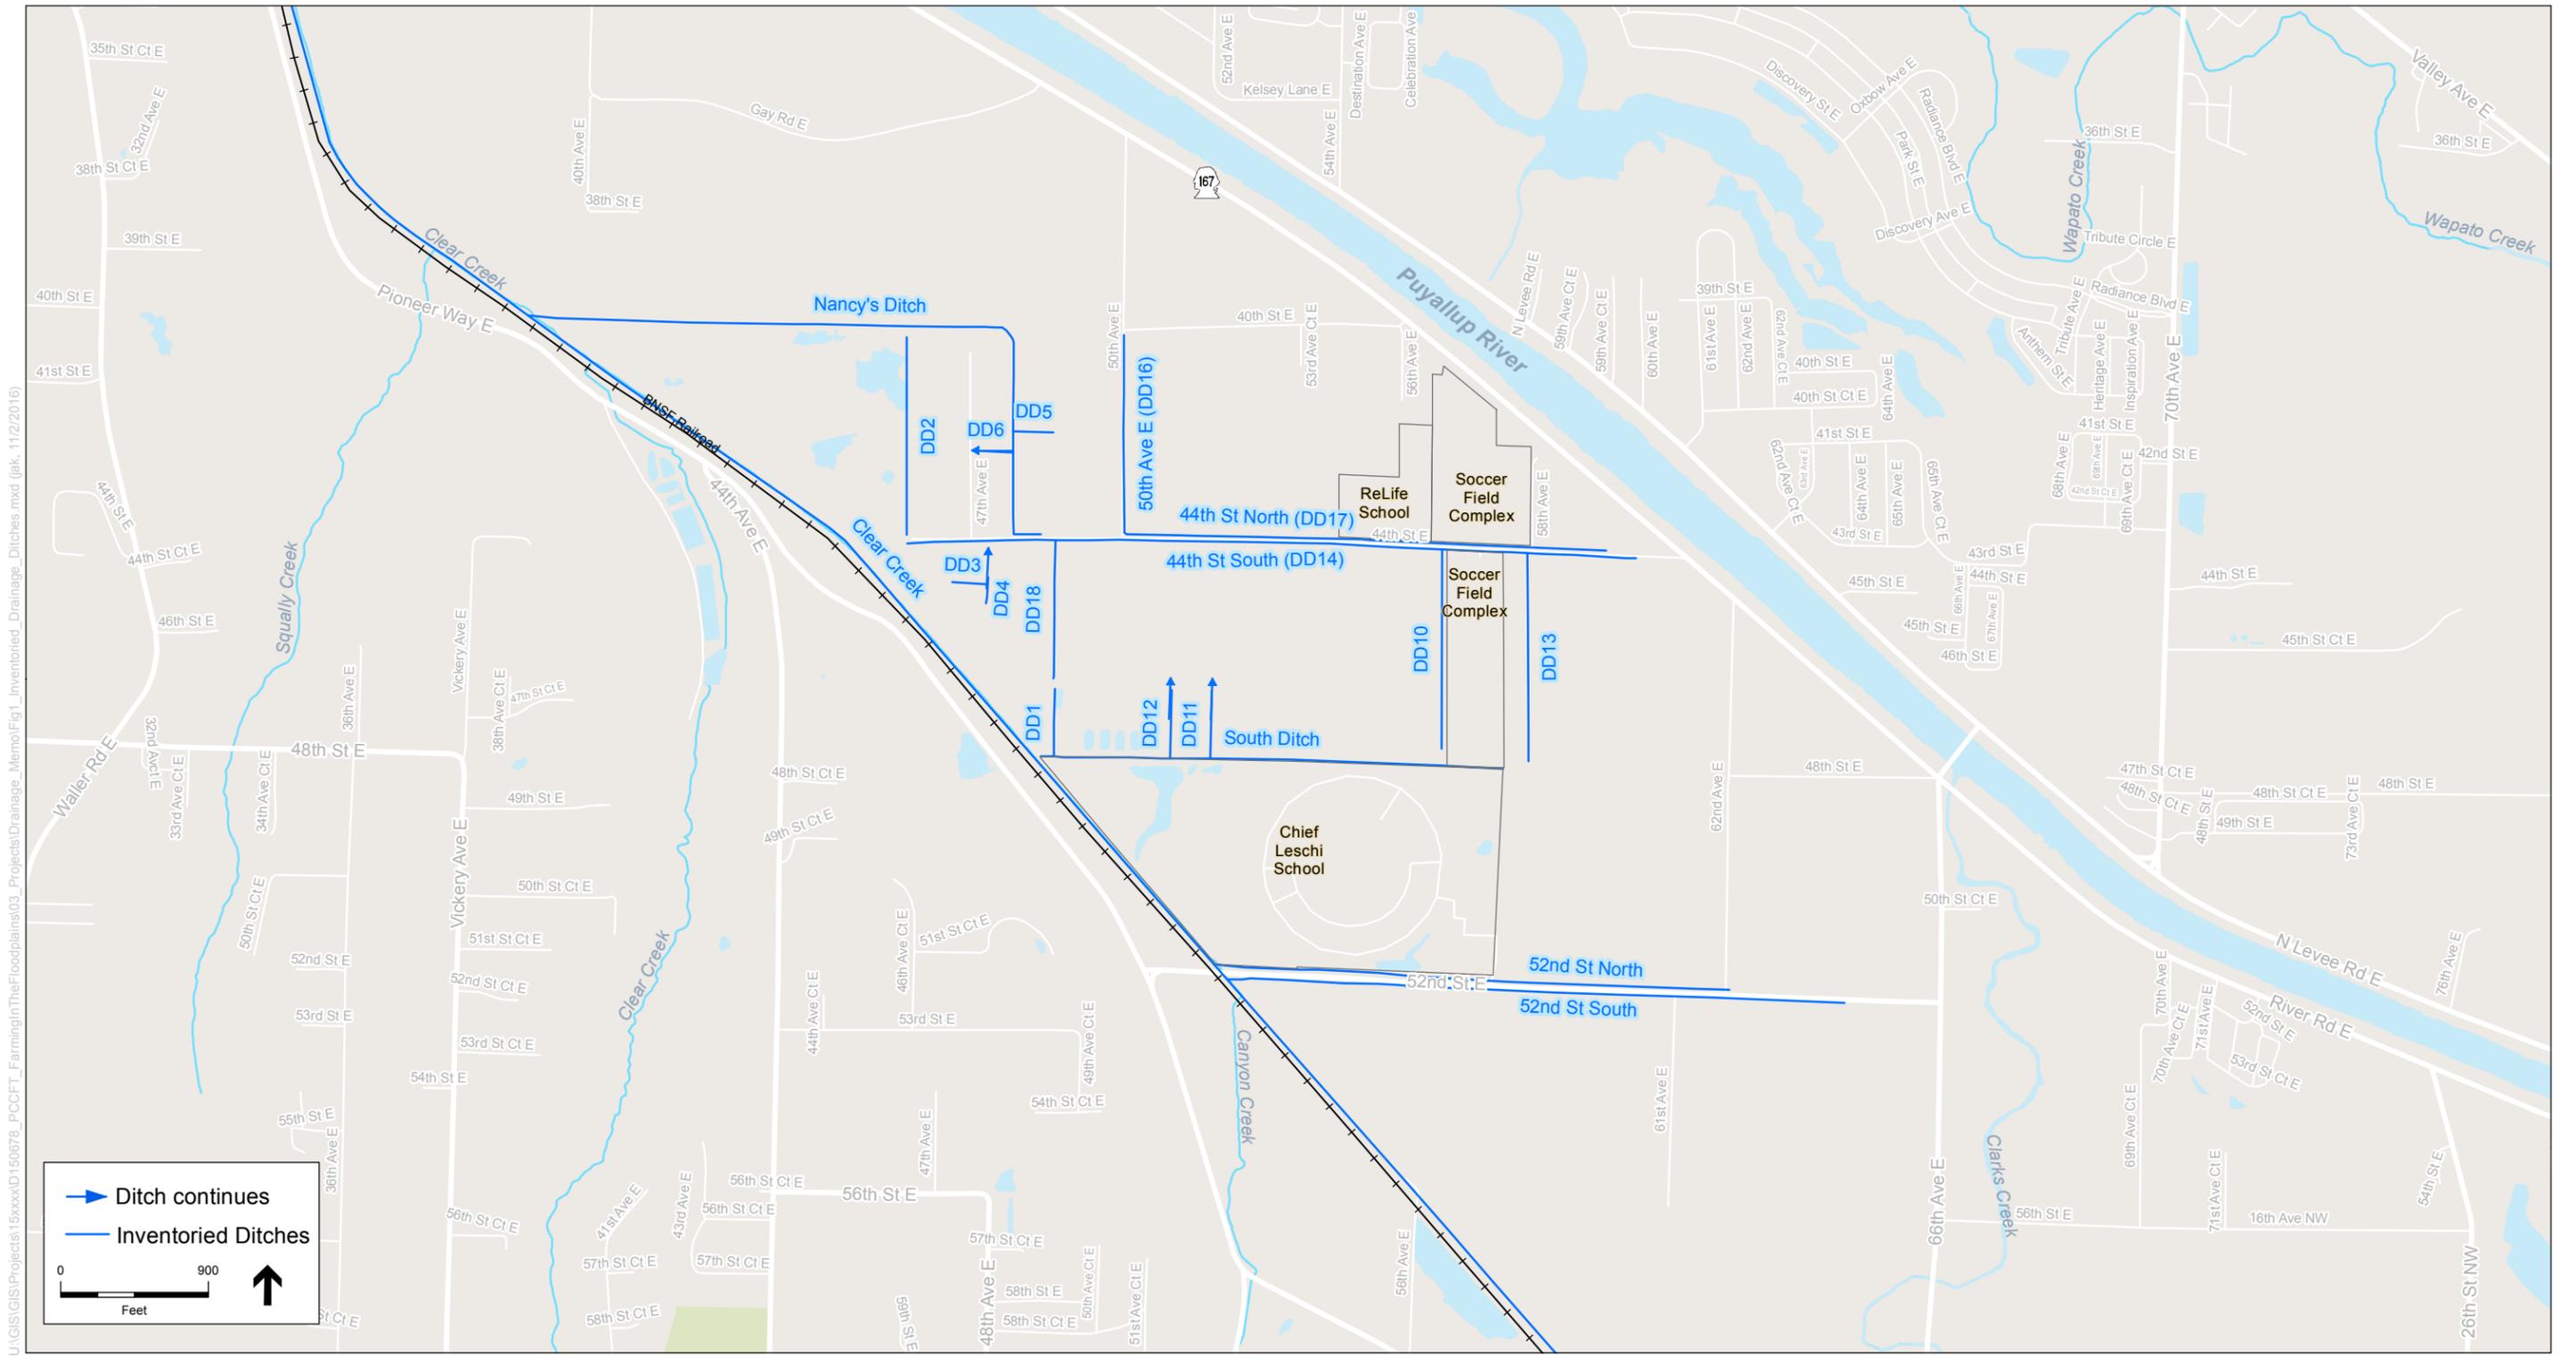
Figure 2
Inventoried Drainage Ditches

Instead of flowing west into Clear Creek, South Ditch now drains to three seemingly poorly maintained and narrow private drainage ditches (Figure 2). These ditches carry flows from South Ditch north to the roadside drainage ditch on the south side of 44th Street. From there, water flows into Nancy's Ditch, where it flows north then west, entering Clear Creek approximately 4,000 feet downstream of the original outlet of South Ditch.

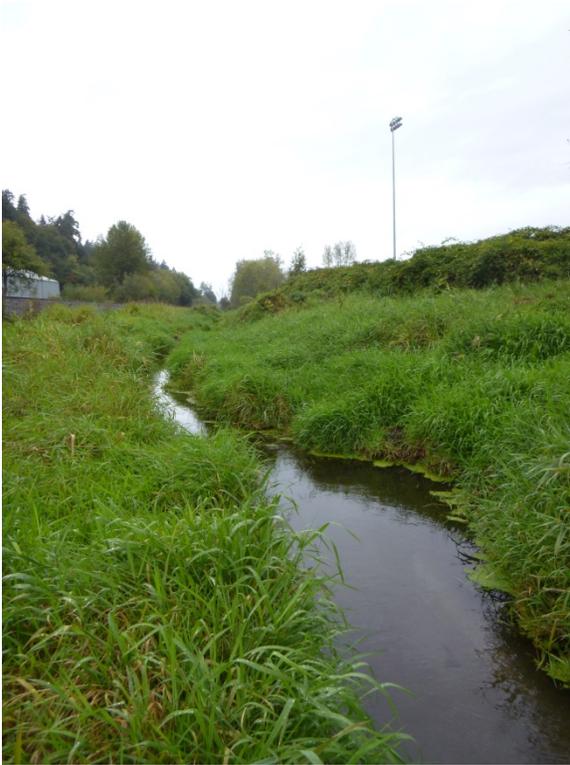
Photo 1. Clear Creek facing downstream from the 52nd Street East culvert

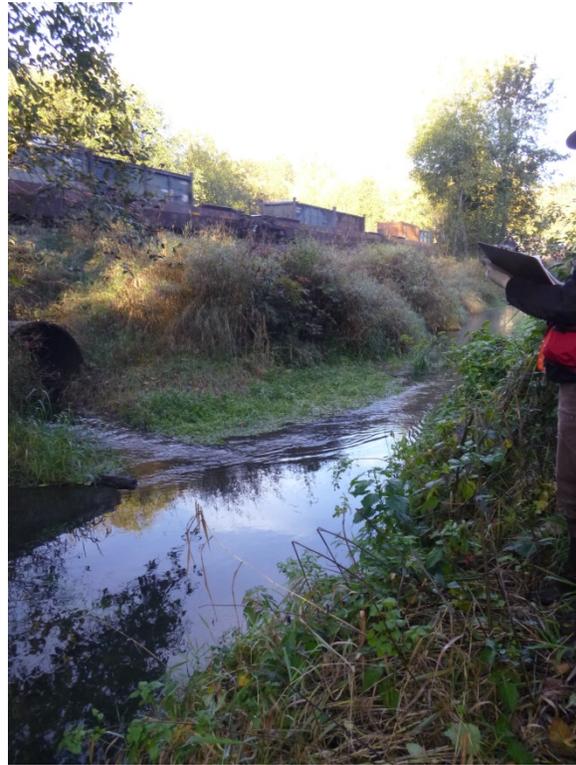
Photo 2. Squally Creek flows through a culvert under the railroad tracks and into Clear Creek

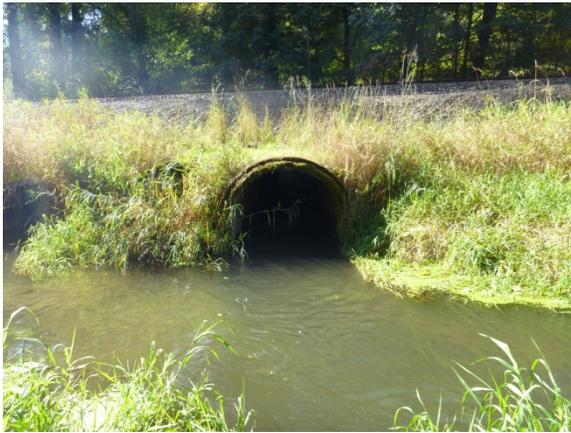
Photo 3. Upper Clear Creek flows into Clear Creek via two culverts that cross under the railroad tracks

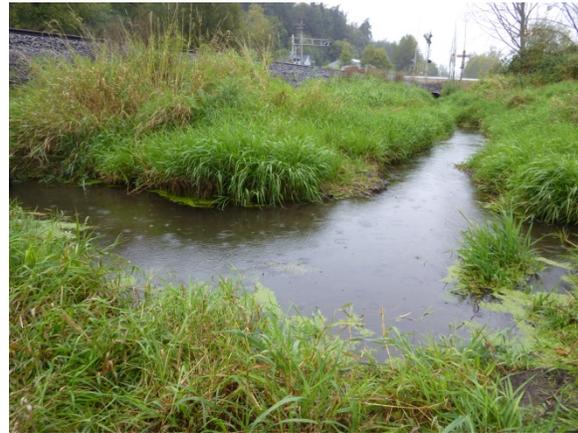
Photo 4. Canyon Creek (left) flows into Clear Creek

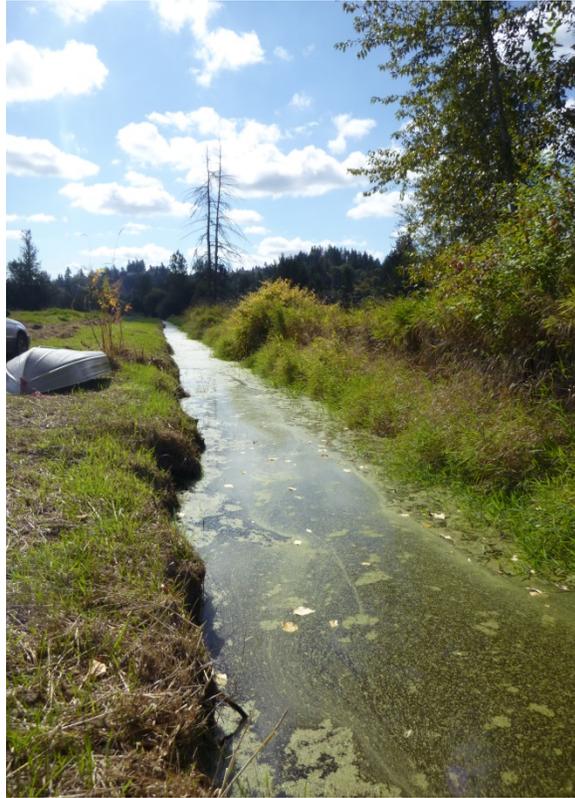
Photo 5. North end of north-south reach of Nancy's Ditch, facing south.

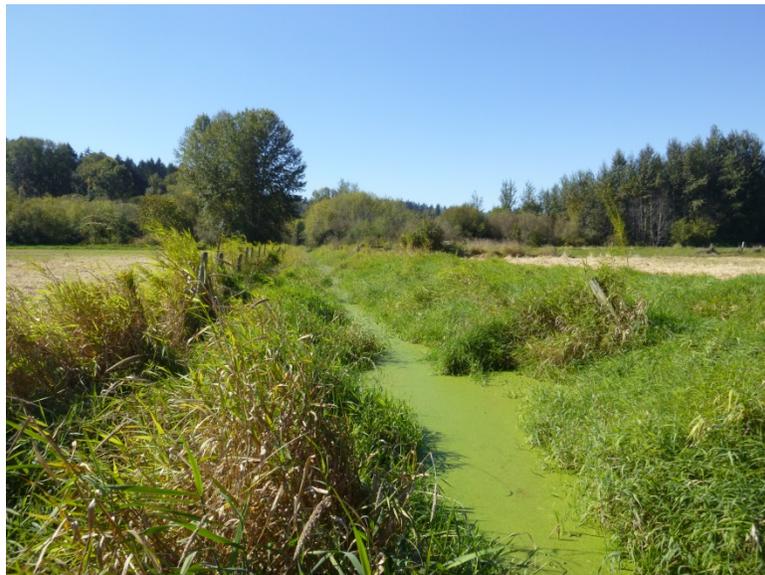
Vegetation. A high density of duckweed was observed covering the majority of the water surface in the channel (Photo 6). Reed canarygrass was also very dense along both banks for the entire length of Nancy's Ditch. In many areas of the channel, reed canarygrass was observed growing within the channel, impeding water flow, and potentially raising the water level upstream and slowing velocity.

Photo 6. East-west reach of Nancy's Ditch. Reed canarygrass is dense on the banks and edges of the channel. Duckweed dominates the water surface

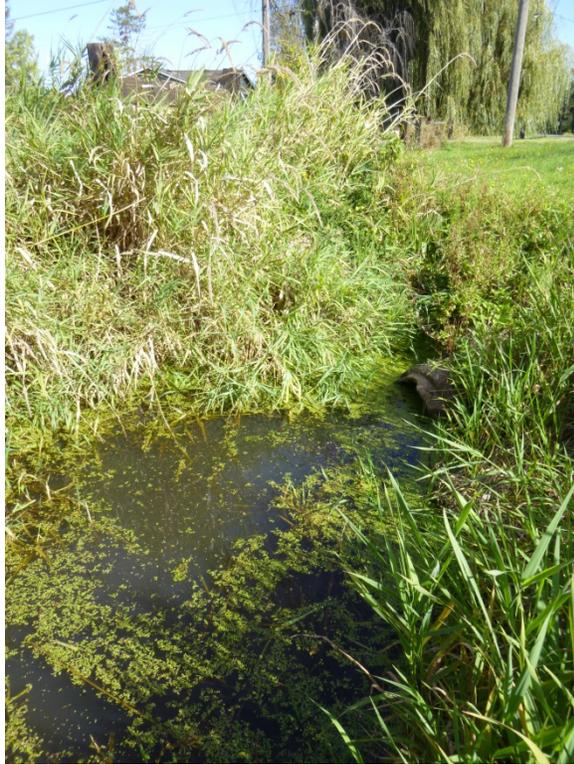
Photo 7. Water in western portion of 44th Street North ditch and DD17-Culvert 5

Vegetation. There was very dense reed canarygrass growing in and on the banks along the majority of 44th Street North Ditch (Photo 7). In the separate western portion of the ditch, less dense reed canarygrass was observed and duckweed was dominant where surface water was present. The channel appeared to be maintained from the front of ReLife School to the east end of the ditch. There is short weedy vegetation in the channel, but little to no reed canarygrass along this portion.

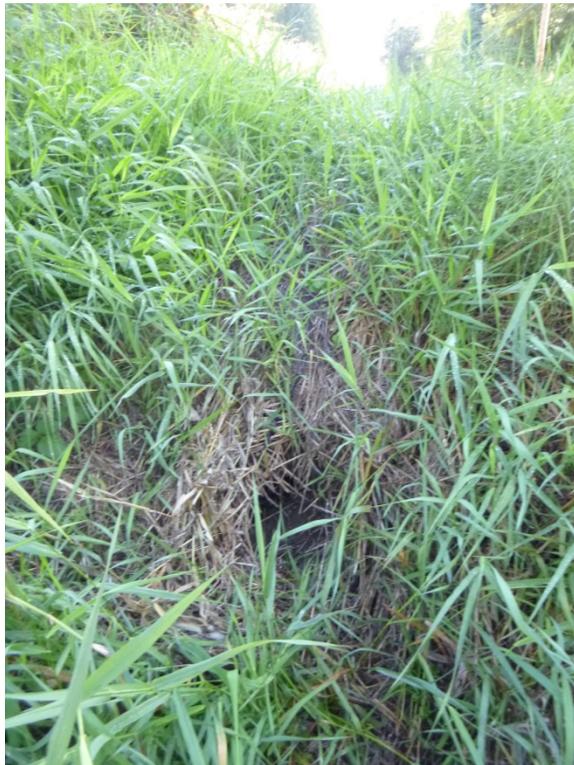
Photo 8. Culvert partially obstructed by reed canarygrass in 44th Street North ditch

Culverts. A total of 10 culverts were observed in the 44th Street North ditch, mostly under driveway and road crossings. All ranged between 1 and 2 feet in diameter. Some culverts appeared to be partially obstructed by sediment and by dense reed canarygrass growing in the channel (Photo 8).

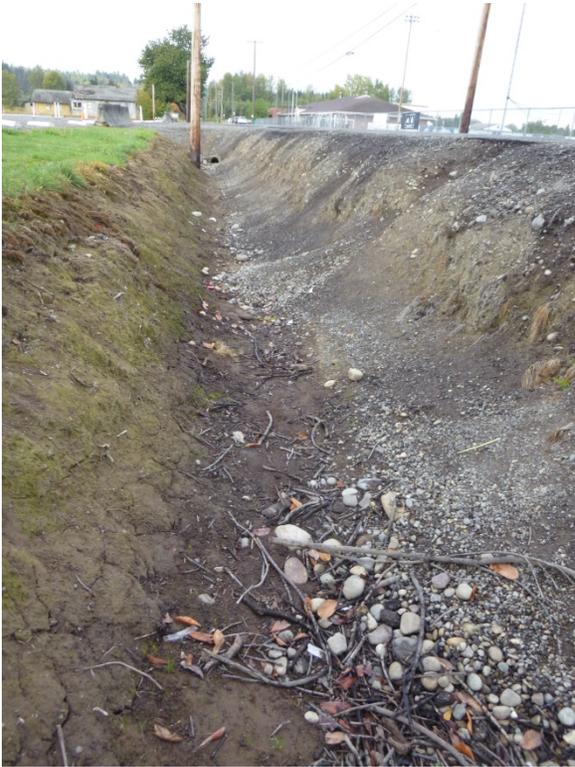
Photo 9. 44th Street South ditch adjacent to the soccer fields

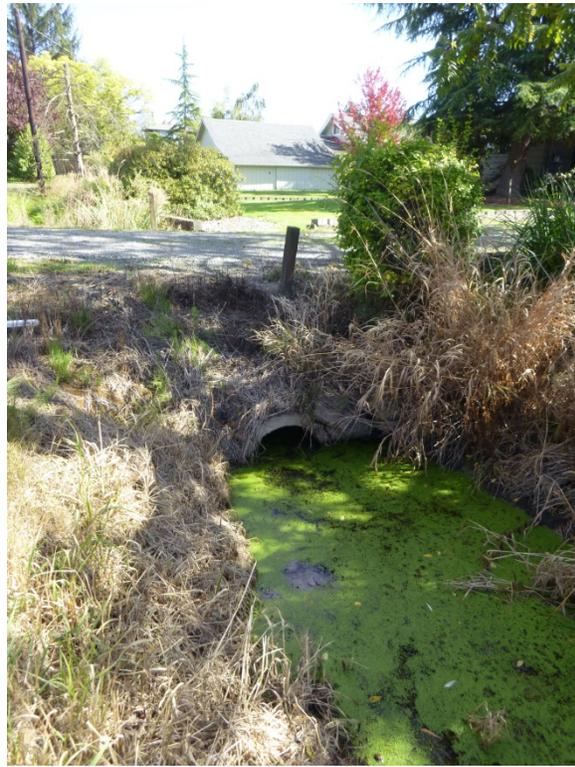
Culverts. There were 24 culverts observed along the length of the 44th Street South ditch, mostly under driveways and the road shoulder. Photo 10 shows an example culvert on the 44th Street South ditch. Many culverts appeared to be partially obstructed by sediment, reed canarygrass, and/or Himalayan blackberry.

Photo 10. 44th Street South ditch and culvert, west of 50th Avenue East

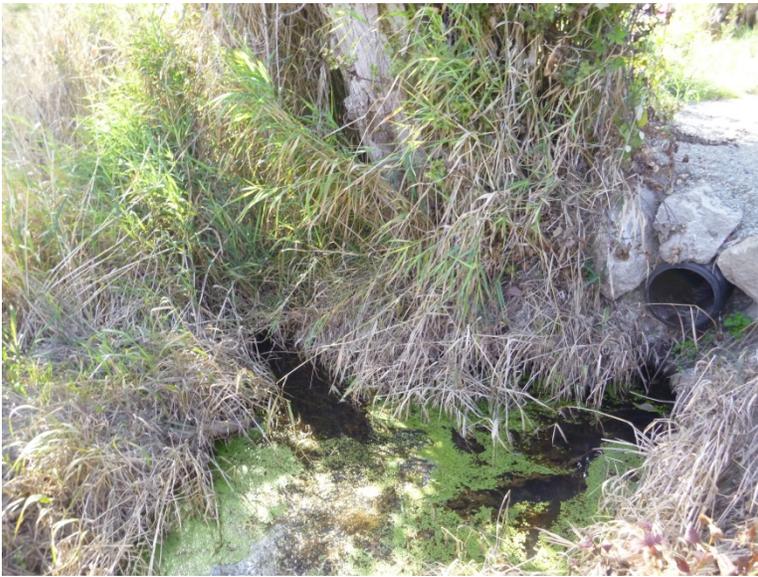
entrances to these culverts. In addition, a perched culvert (DD14-Culvert10) was observed on top of DD17-Culvert 5 approximately 1.9 feet above the channel bed (Photo 11). Unlike DD17-Culvert 5, DD14-Culvert 10 is oriented east-west. The fact that the culvert is perched likely impedes the westerly flow of water in the 44th Street South ditch east of this point when the water level is below the culvert. However, DD17-Culvert 5 is located at the bottom of the channel below DD14-Culvert 10, so even when the water level is low, drainage of the eastern portion of 44th South Ditch to the 44th North Ditch could still potentially occur.

Photo 11. Perched culvert in 44th Street South ditch. A second culvert that flows under the road and into 44th Street North ditch is located below it in the channel.

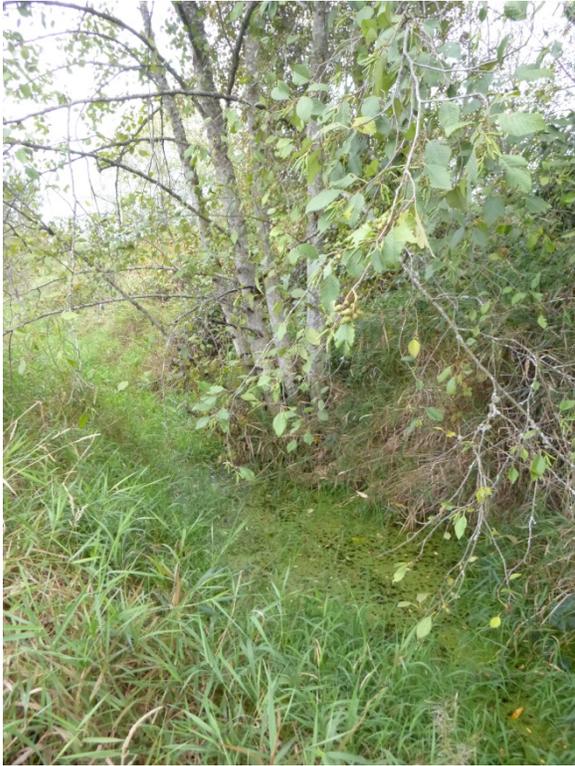
Photo 12. South Ditch between Drainage Ditches 11 and 12. Dense reed canarygrass dominates both banks. Duckweed is dense in the channel. Red alder overhangs the channel.

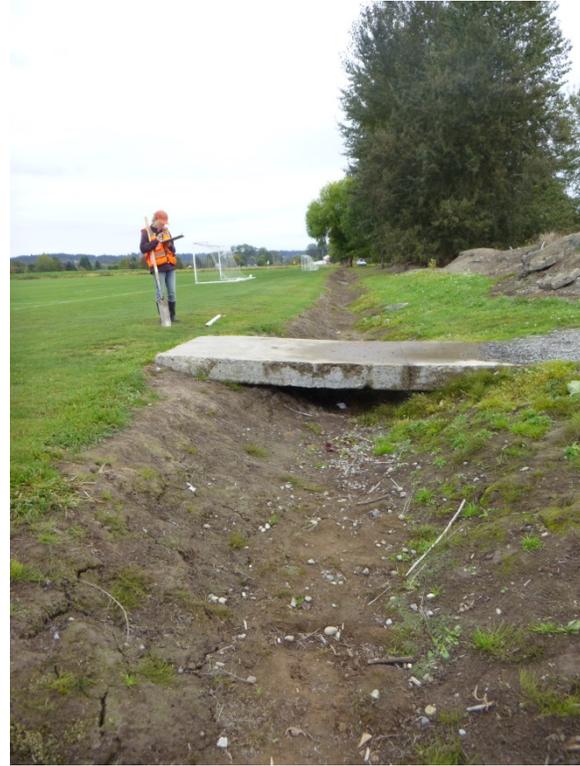
There is a concrete footbridge crossing South Ditch at the west end of the soccer fields (Photo 13). It is approximately four feet wide and positioned one foot above the channel bed and could be an impediment to water flow in the ditch under certain conditions when the water level reaches the bridge bottom.

Photo 13. South Ditch is maintained south of the soccer fields.

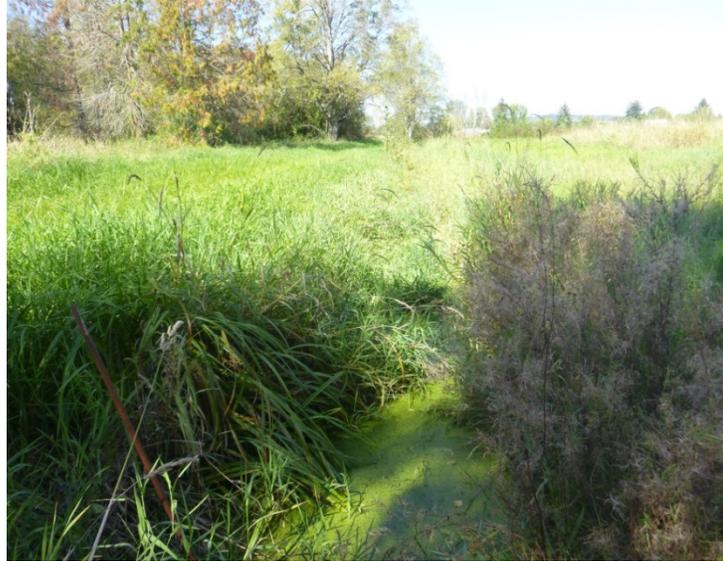
Photo 14. Drainage Ditch 1, facing north from South Ditch

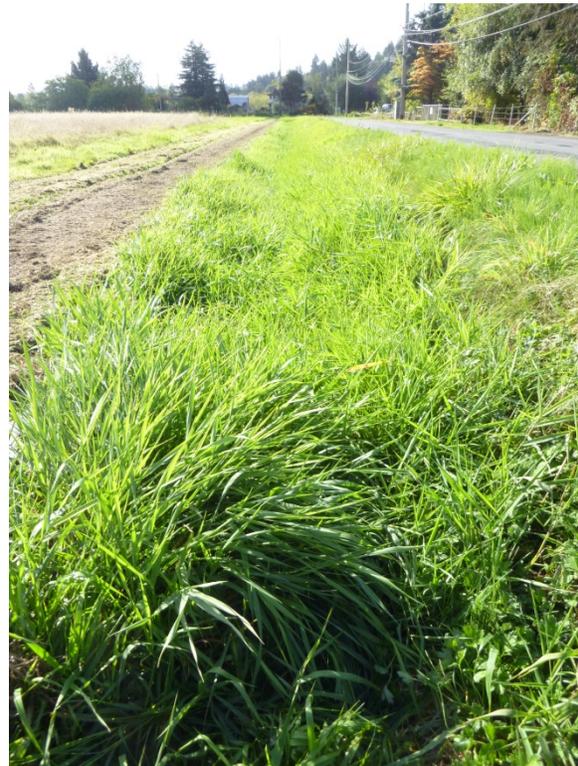
Vegetation. The entire length of the channel was dominated by reed canarygrass, and no shrubs or trees were present (Photo 15).

Photo 15. 50th Avenue East ditch facing south toward 44th Street

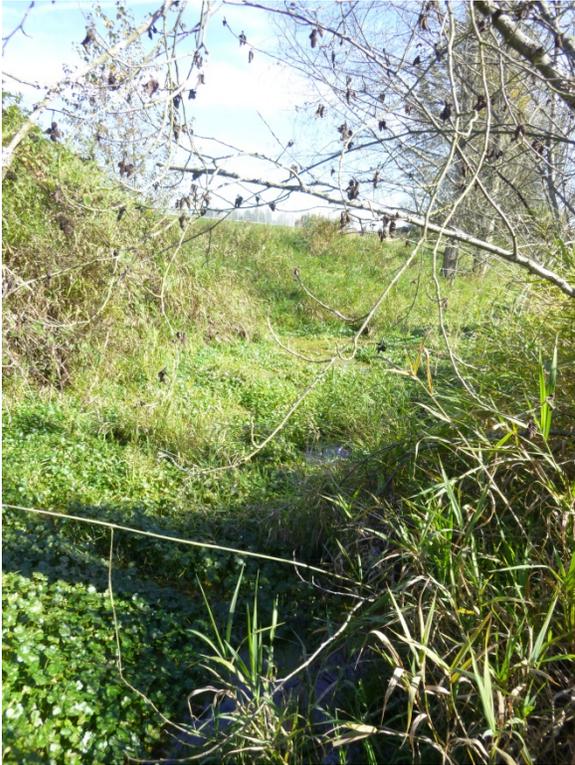
Similar to 52nd Street South ditch, the 52nd North ditch had dense reed canarygrass growing on the banks and in the channel. Water pennywort was also observed growing in a dense mat across the channel at the west end. A patch of dense cattails were also observed to the east of where the 52nd Street North ditch connects to Clear Creek.

Photo 16. 52nd Street North ditch near Clear Creek, facing east

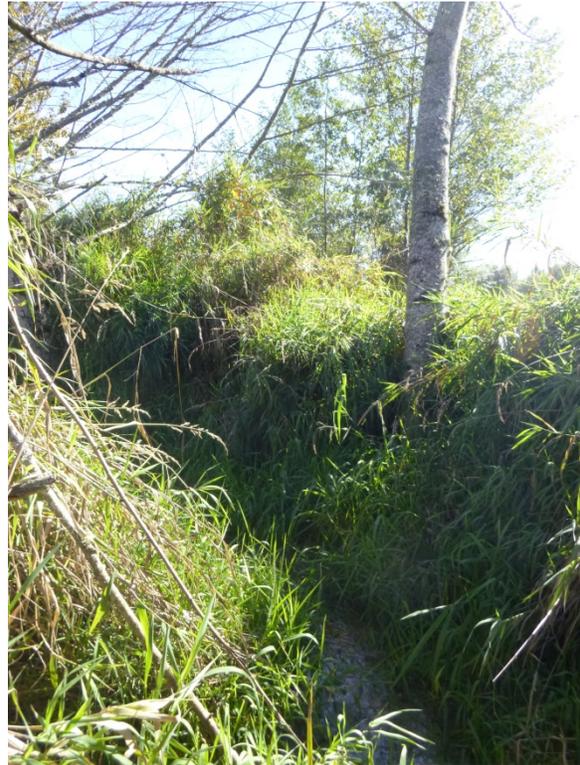
Vegetation. Field investigators observed dense reed canarygrass growing on the banks as well as in the channel of the 52nd Street South ditch (Photos 16 and 17). In open water areas without reed canarygrass growth, there was dense duckweed. East of the intersection of the ditch with Clear Creek, field investigators observed a patch of cattails. Other vegetation on the banks included blackberry, red alder, and black cottonwood. Further east, some vegetation was observed in the channel, but little to no reed canarygrass.

Photo 17. 52nd Street South ditch near Clear Creek, facing east
