FINAL DRAINAGE INVENTORY MEMORANDUM

Farming in the Floodplain Project

Prepared for
PCC Farmland Trust

May 2017

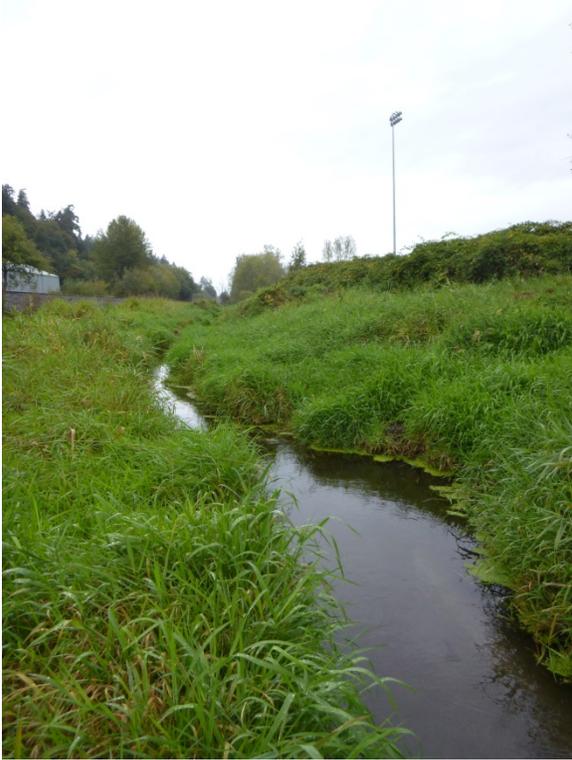
Channel Condition. Several stretches of the Clear Creek channel were observed to have stable banks. In other areas, unstable and undercut banks were observed. A majority of the channel bed was covered with a thick layer of soft, very fine sediment, 1 foot deep in some areas and over 3 feet deep in other areas. The bank height ranged from 3.8 feet to 10 feet, and the channel width ranged from 18 to 40 feet at the top of the bank. Water depth, measured from the top of the soft sediment, ranged from just under 1 foot to approximately 7 feet. During the wet season site visit, field investigators observed increased turbidity in Clear Creek from the Canyon Creek junction downstream to Gay Road East. In addition, water depths had increased to more than 11.5 feet.

Vegetation. Throughout Clear Creek, field investigators commonly observed dense reed canarygrass growth within the channel and on the channel banks. Within the channel, reed canarygrass was often so dense that it appeared to impede water flow. In other areas, recent maintenance activities had cleared the channel of reed canarygrass (Photo 1). Other vegetation species observed growing in the channel in moderate density included duckweed and another aquatic plant species assumed to be elodea. Himalayan blackberry was common on the channel banks and made areas of the channel inaccessible to investigators.

Photo 1. Clear Creek facing downstream from the 52nd Street East culvert

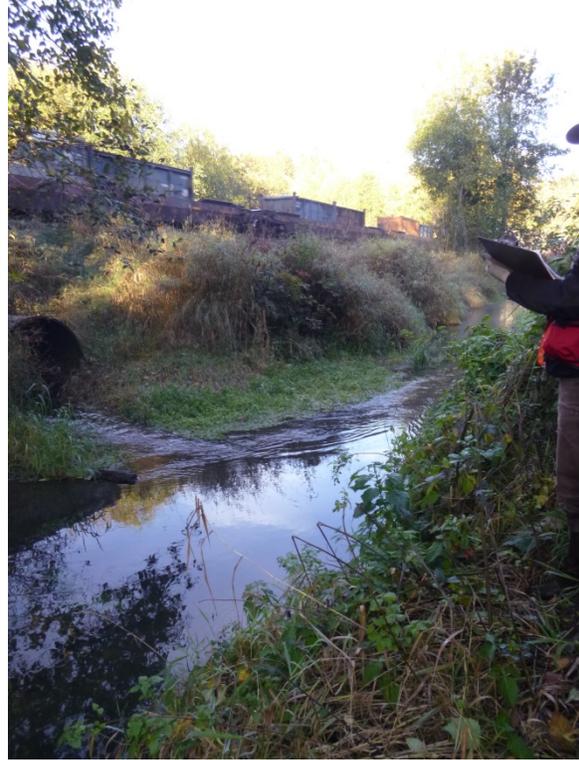
Photo 2. Squally Creek flows through a culvert under the railroad tracks and into Clear Creek

Culverts. Canyon Creek, upper Clear Creek, and Squally Creek enter Clear Creek through several culverts under the BNSF Railway line (Photos 2 through 4). The majority of these culverts range between 4 and 6 feet in diameter. A number of culverts appeared to be partially obstructed by sediment and/or reed canarygrass. Another culvert under the BNSF Railway line, between the outlets of Canyon Creek and upper Clear Creek, drains a stormwater retention pond into Clear Creek. Based on information provided by Drainage District 10, the stormwater retention pond appears to drain stormwater from around 30 residential properties on the south side of the BNSF Railway line and Pioneer Way. This culvert was not inventoried during ESA's field work, but it was observed by ESA staff on April 24, 2017. Clear Creek flows through culverts under 52nd Street East and Gay Road East. At the inlets of the Gay Road East culverts, woody debris, a very large rock, and trash debris were observed. During the wet season field visit, water levels in Clear Creek were near the top of the Gay Road East culverts.

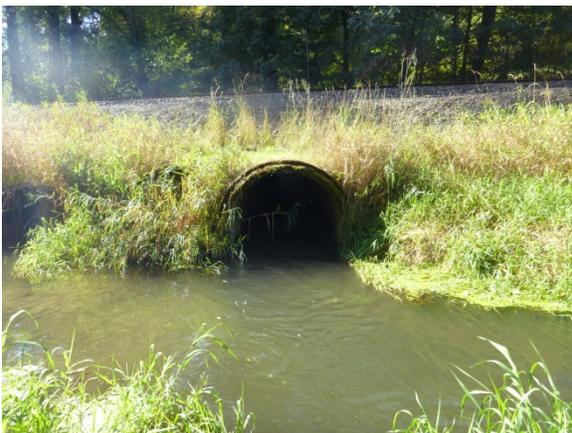
Photo 3. Upper Clear Creek flows into Clear Creek via two culverts that cross under the railroad tracks (photo is of culvert outlets)

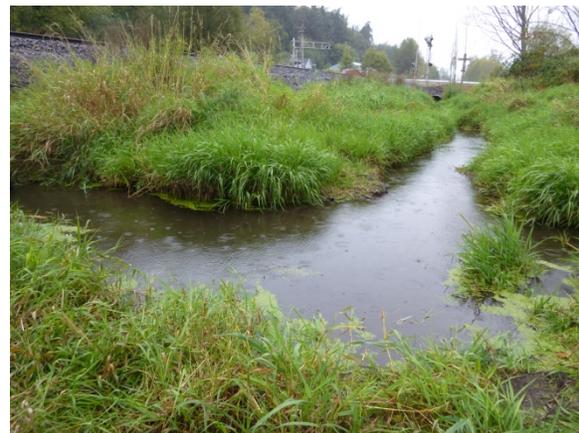
Photo 4. Canyon Creek (left) flows into Clear Creek

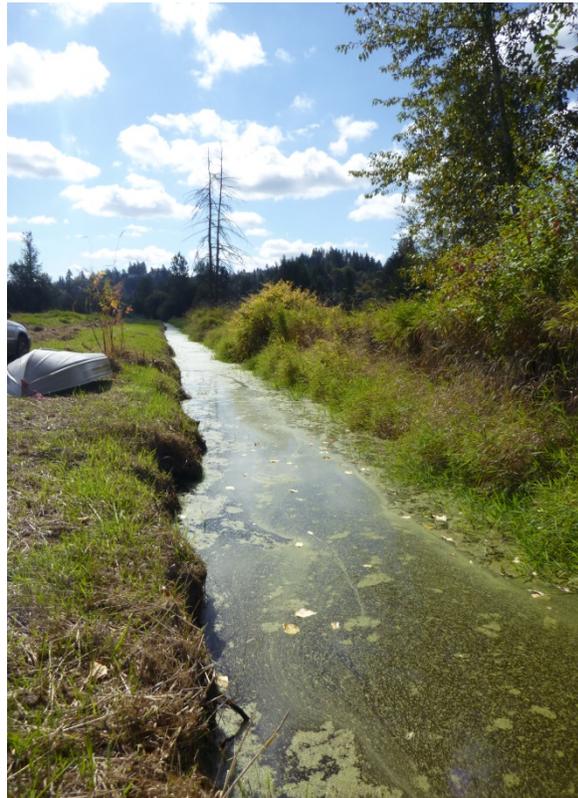
Channel Condition. The majority of the channel banks appeared to have limited areas of erosion and undercutting. Field investigators observed a thick layer of silty sediment along the channel bed, roughly 2.5 feet deep in places. The channel ranged between 15 and 26 feet in width at the top of the bank.

Photo 5. North end of north-south reach of Nancy's Ditch, facing south.

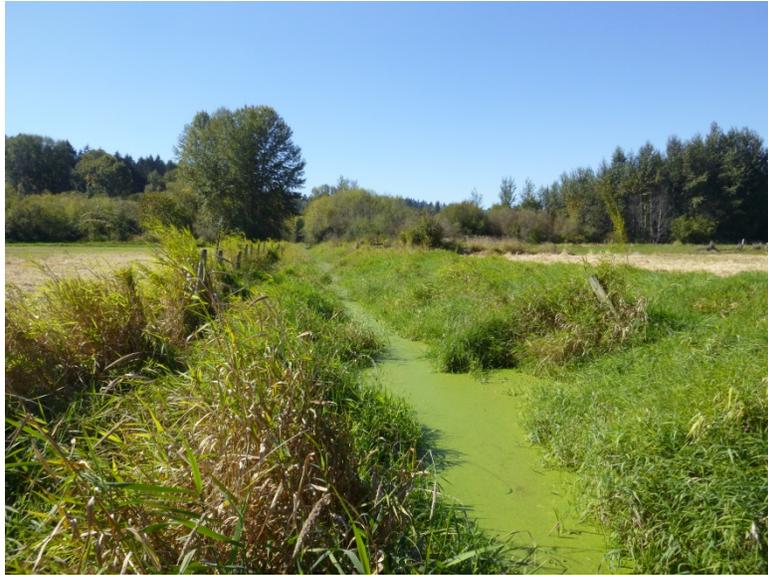
Vegetation. A high density of duckweed was observed on the water surface (Photo 6). Reed canarygrass was very dense along both banks for the entire length of Nancy's Ditch. In many areas of the channel, reed canarygrass was observed growing within the channel, impeding water flow and potentially increasing water levels upstream. During the wet season site visit, field investigators observed little to no duckweed on the water surface; however, reed canarygrass growth within the channel remained the same.

Photo 6. East-west reach of Nancy's Ditch. Reed canarygrass is dense on the banks and edges of the channel. Duckweed dominates the water surface

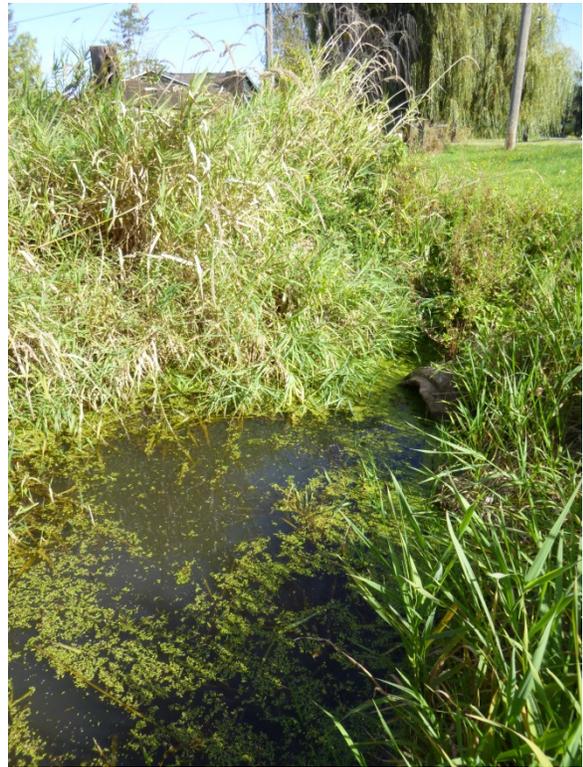
Photo 7. Water in western portion of 44th Street North Ditch and DD17-Culvert 5

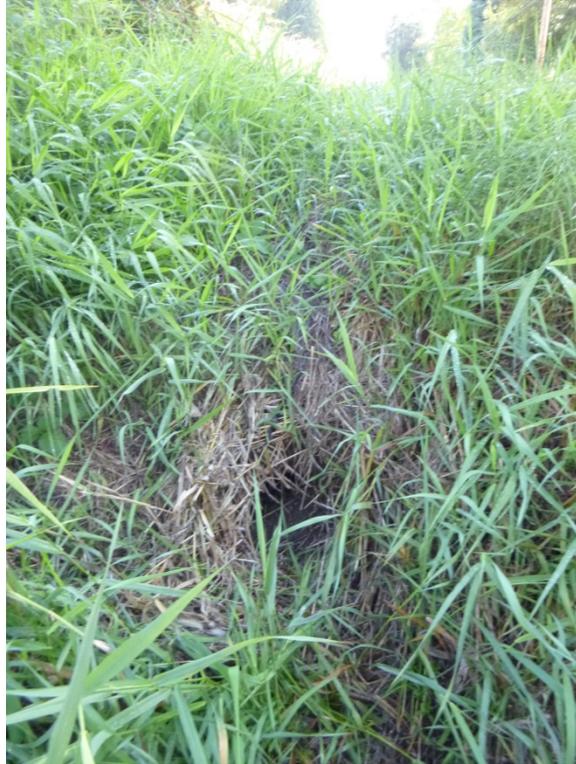
Photo 8. Culvert partially obstructed by reed canarygrass in 44th Street North ditch

Culverts. Ten culverts were observed in the 44th Street North Ditch, mostly under driveway and road crossings. All culverts ranged between 1 and 2 feet in diameter. Some culverts appeared to be partially obstructed by sediment and by dense reed canarygrass growing in the channel (Photo 8).

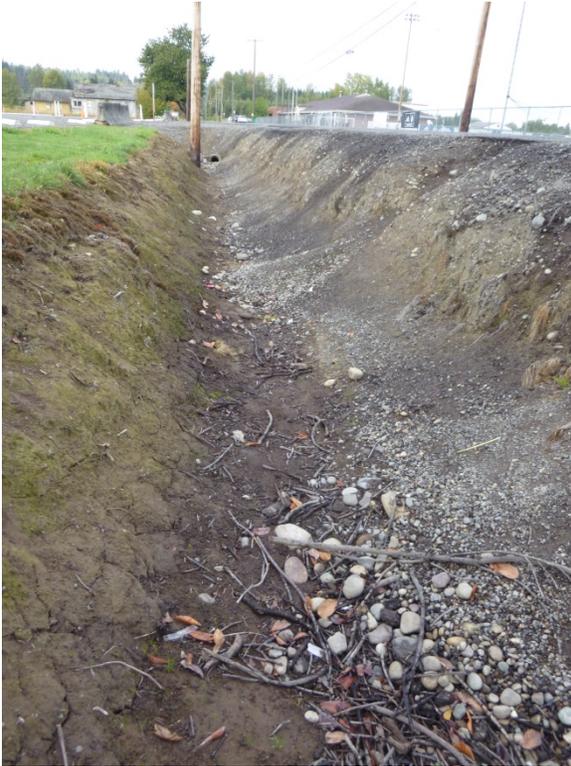
Photo 9. 44th Street South Ditch adjacent to the soccer fields

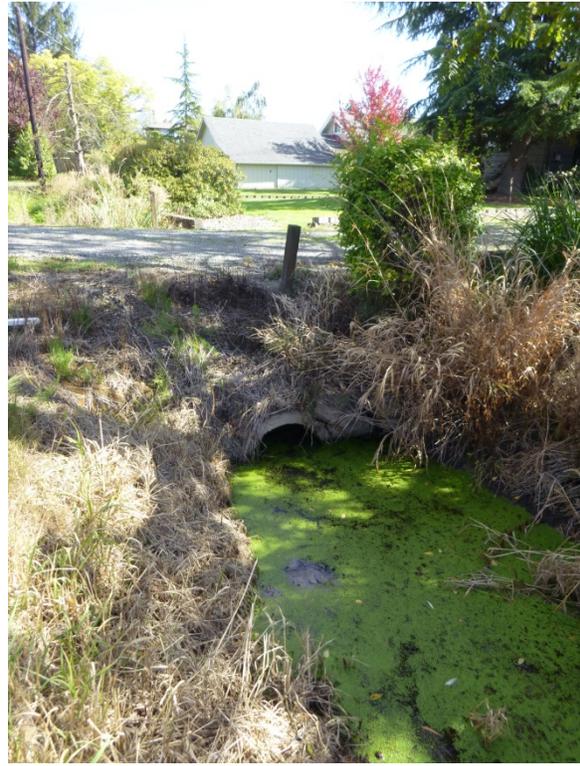
Culverts. Twenty-four culverts were observed along the length of the 44th Street South Ditch, mostly under driveways and the road shoulder. Photo 10 shows one of the culverts on the 44th Street South Ditch. Many culverts were partially obstructed by sediment, reed canarygrass, and/or Himalayan blackberry.

Photo 10. 44th Street South Ditch and culvert, west of 50th Avenue East

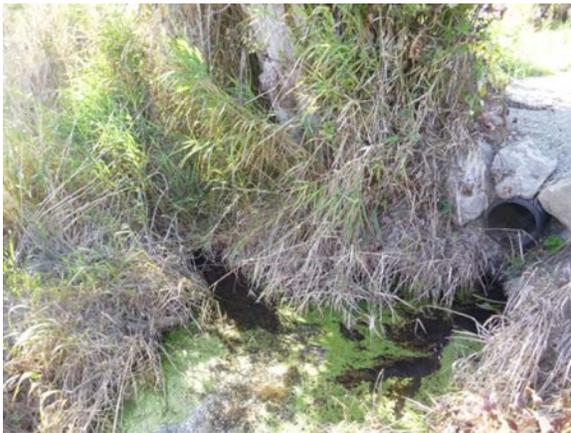
Photo 11. Perched culvert in the 44th Street South Ditch. A second culvert that flows under the road and into the 44th Street North ditch is below it in the channel.

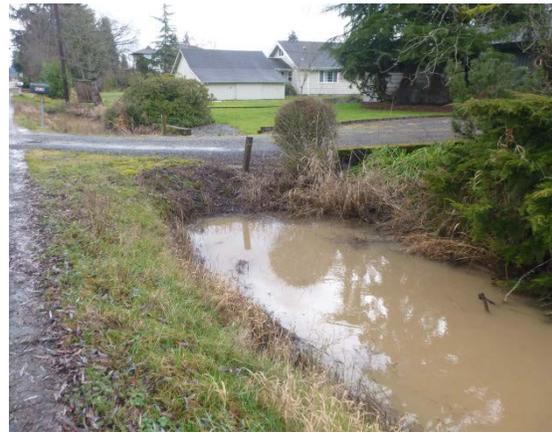
Photo 12. Water levels above the top of a culvert along the 44th Street South Ditch, observed during the wet season site visit.

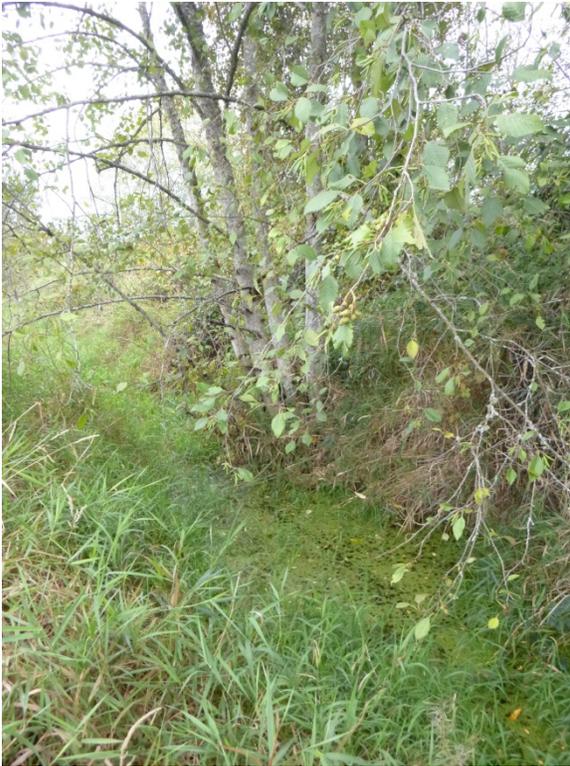
Photo 13. South Ditch between Drainage Ditches 11 and 12. Dense reed canarygrass dominates both banks. Duckweed is dense in the channel. Red alder overhangs the channel.

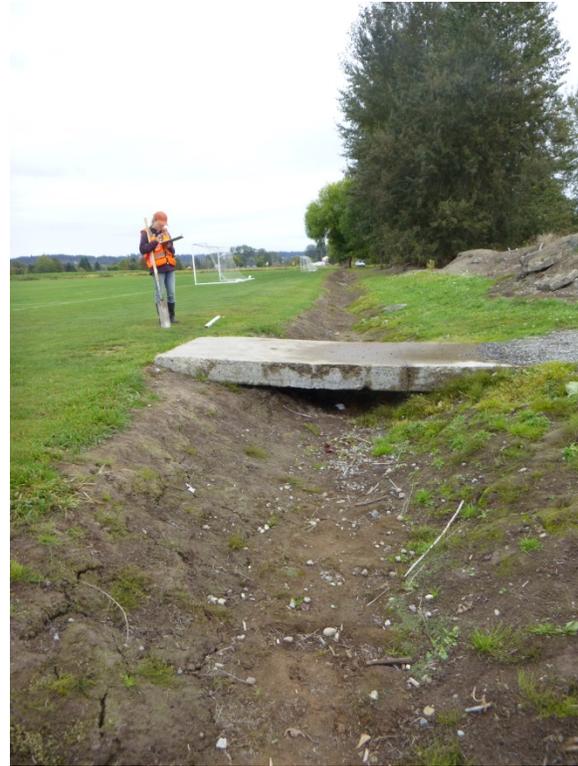
Vegetation. South Ditch appeared to be maintained at the east end, south of the soccer fields. No vegetation was observed in the channel, and both banks were mowed. Reed canarygrass was the dominant species west of the soccer fields and was observed growing in dense mats within the channel and along the banks. Duckweed covered much of the water surface (Photo 13). Black cottonwood, red alder, Pacific willow, Sitka willow, Oregon ash, and Himalayan blackberry were observed along the south bank and adjacent to the channel. During the wet season visit, no duckweed was observed on the water surface.

Photo 14. South Ditch is maintained south of the soccer fields.

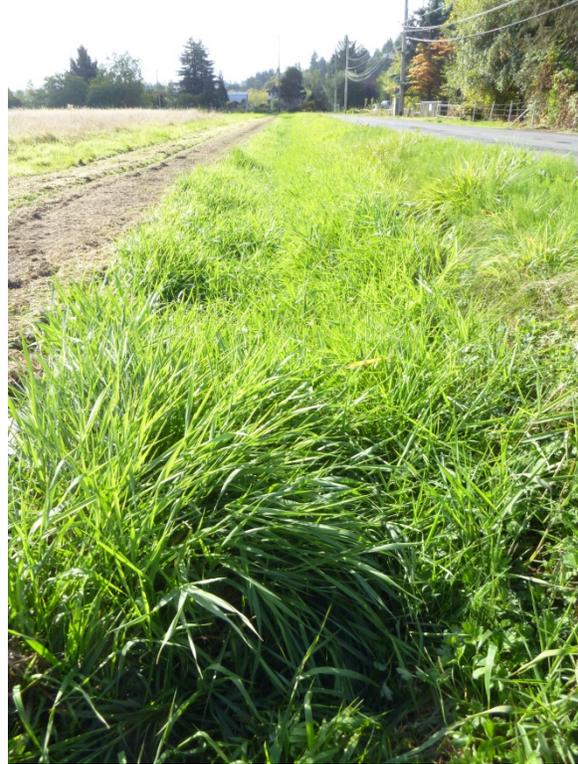
Vegetation. The entire length of the channel was dominated by reed canarygrass, and no shrubs or trees were present (Photo 15).

Photo 15. 50th Avenue East ditch facing south toward 44th Street

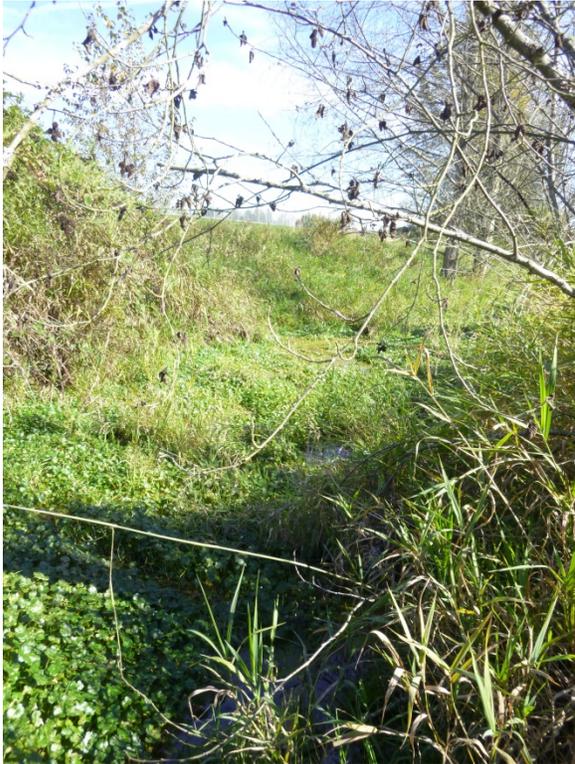
Similar to the 52nd South Ditch, the 52nd North Ditch had dense reed canarygrass on the banks and in the channel. Water pennywort was also observed growing in a dense mat across the channel at the west end. A dense patch of cattails was also observed to the east of where the 52nd North Ditch connects to Clear Creek.

Photo 16. 52nd North Ditch near Clear Creek, facing east

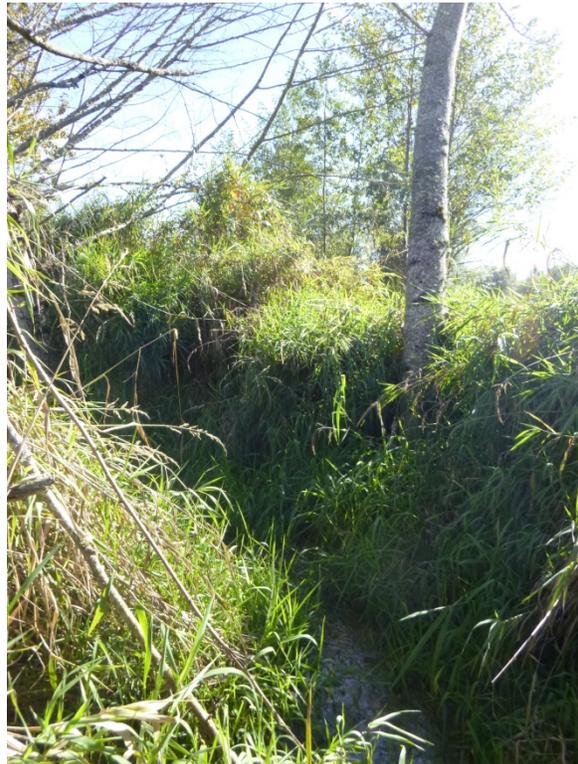
Vegetation. Dense reed canarygrass was observed growing on the banks as well as in the channel of the 52nd South Ditch (Photos 16 and 17). In open water areas without reed canarygrass, there was dense duckweed. East of the intersection of the ditch with Clear Creek, field investigators observed a patch of cattails. Other vegetation on the banks included blackberry, red alder, and black cottonwood. Farther east, some vegetation was observed in the channel but little to no reed canarygrass.

Photo 17. 52nd South ditch near Clear Creek, facing east

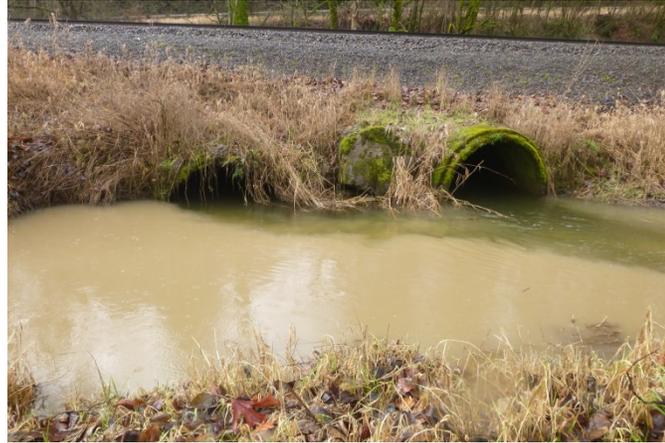
During the wet season field visit, at the culverts where upper Clear Creek and Squally Creek enter Clear Creek, field investigators observed that water entering from the tributaries was significantly less turbid than the water in Clear Creek (Photo 18).

Photo 18. Culverts conveying upper Clear Creek into Clear Creek on January 19, 2017. Water from upper Clear Creek was substantially less turbid than water in Clear Creek.

Addressing the accumulation of sediment would improve the agricultural drainage system. More information on sources of sediment and approaches to address sediment are included in the [Sediment Conditions in the Puyallup River and Clear Creek](#) Technical Memorandum (ESA, 2016b).

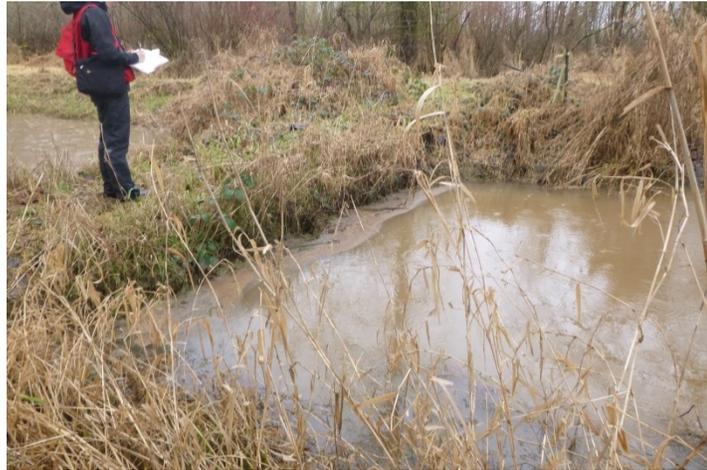
Nancy's Ditch flows through four small culverts directly adjacent to each other before entering Clear Creek. Each culvert is 2.4 feet in diameter. During the dry season field visits, sediment was observed in the culverts. During the wet season field visit, the culverts had some debris at their inlets. While water was flowing through the culverts, water flow was faster on the outlet side of the culverts, suggesting that the culverts may be constricting water flow. Water was observed near the top of the culverts (approximately 0.3 inch from the top) but not overtopping the culverts. Water in Nancy's Ditch upstream of the culverts was at bankfull height (Photo 19).

Photo 19. Nancy's Ditch flowing through four culverts before entering Clear Creek on January 19, 2017
