CLEAR CREEK TIDE GATE ASSESSMENT

Technical Memorandum Farming in the Floodplain Project

Prepared for
PCC Farmland Trust

July 2017

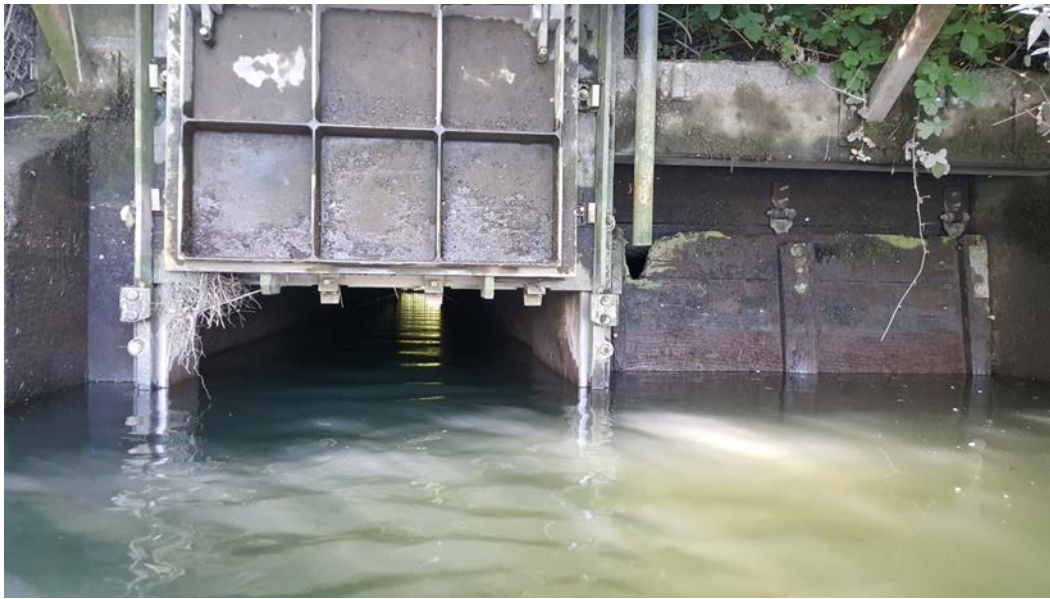
Figure 2 Clear Creek Tide Gate (viewed from the Puyallup River)

The older gate, shown on the right, is a top-hinged wooden flap gate approximately 8 feet wide by 7 feet tall in a wooden frame. The gate is set at an angle of approximately 10 to 15 degrees, with the top set back and the bottom set forward, as shown below in Figure 4 (Port of Tacoma, 1997a). This is a common design for flap gates to make them close more effectively. Ownership of this gate is unclear, and there is no evidence of recent maintenance.

The existing wooden flap gate is old and, based on photographs, appears to be in poor condition. From photographs taken by a Drainage District 10 commissioner in 2016, there appears to be a hole in the top edge of the gate, possibly caused by a beaver chewing the gate (shown on the upper left of the right gate in Figure 2). It is unclear whether the age and lack of maintenance of the gate have led to impairment in the function of the gate because there has been no known recent assessment of the gate's condition. It is possible that its function is impaired, and uncertainty about its condition has created concern that it could fail in a flood event. Due to its weight and the angle at which it is installed, it is unlikely that this gate opens frequently under current conditions. The slide gate side of the culvert provides less resistance, so water would preferentially flow out that direction. Even when the wooden flap gate does open (most likely only during high flows on Clear Creek) it is unlikely to open very much, which may impede drainage from Clear Creek.

Recommendation #2: Assess condition of wooden tide gate and repair if needed

The physical condition of the wooden flap gate should be assessed. The assessment should include evaluation of the water tightness of the gate and seal against opening, the structural condition of the gate itself, and the condition of the hinges. Assessing the physical condition of the wooden flap gate would need to be conducted by a qualified structural engineer. After assessing the gate, the engineer could prepare a memorandum with recommendations for repairing any weaknesses, including a discussion of the risk of delaying repair actions. Based on the recommendations, any urgent repairs should be conducted to ensure the continued reliability of flood protection and tide gate operations. This action could identify needed repairs that could

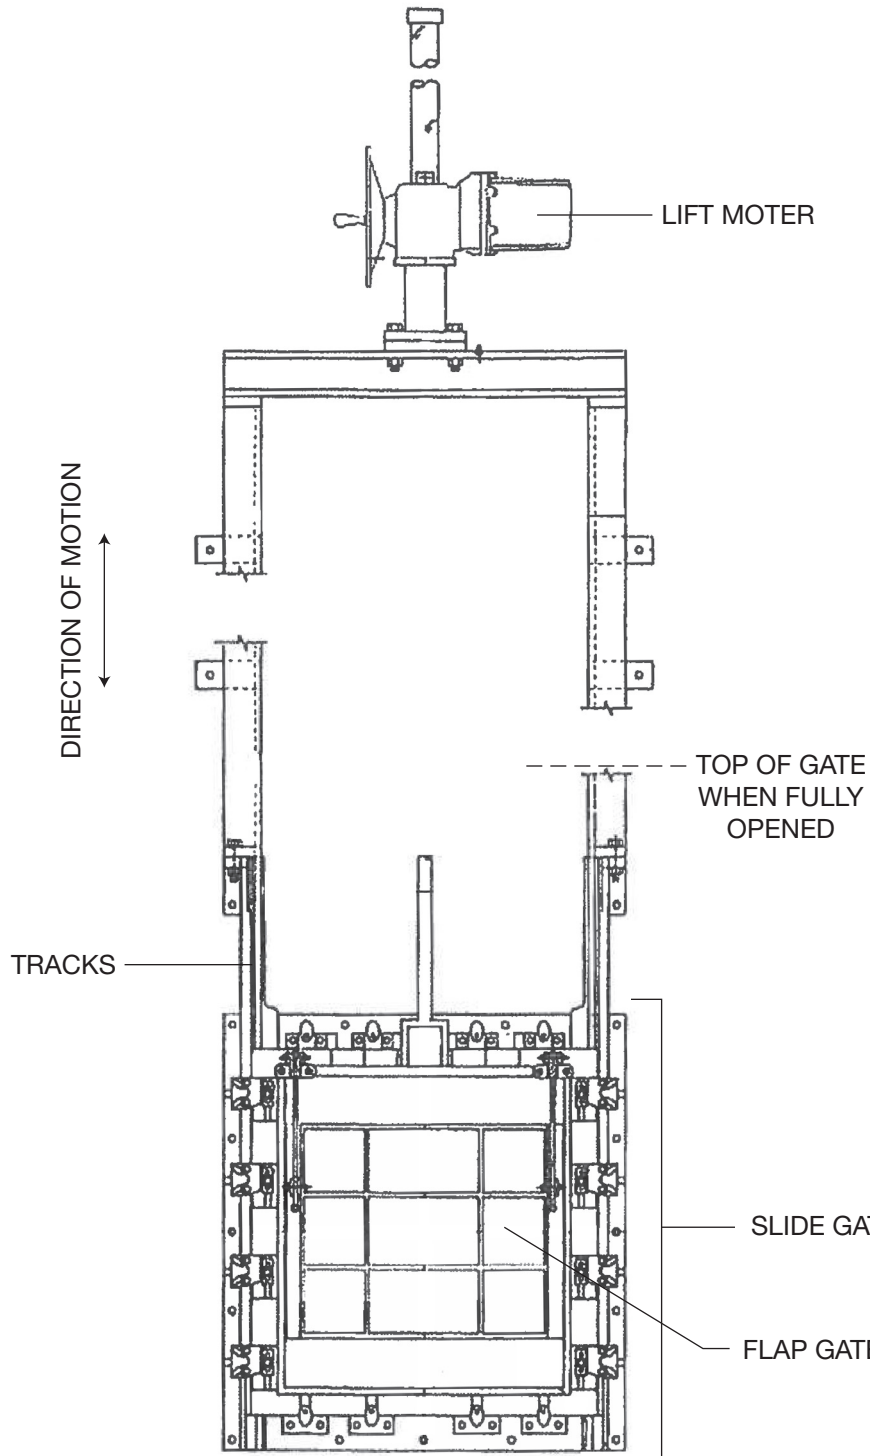
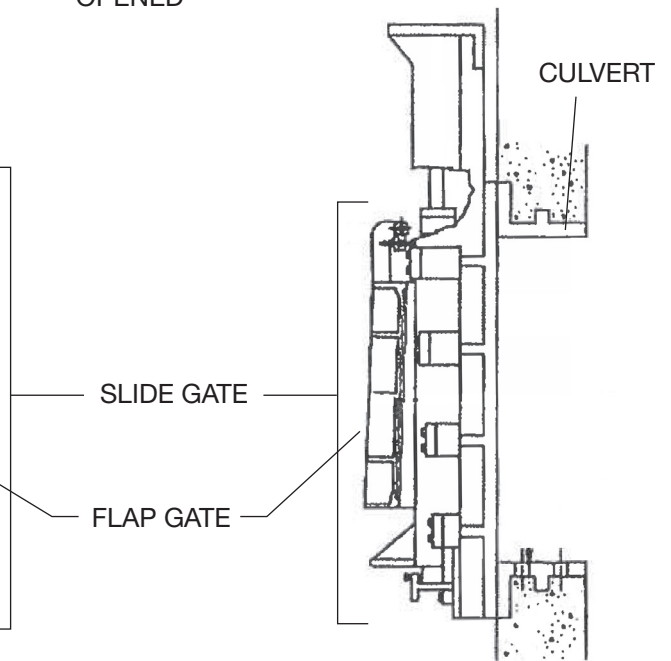
Figure 3

The metal slide gate assembly (on the left in Figure 2) operates using a float-trigger system, which triggers raising and lowering of the slide gate when water levels in the Puyallup River meet

certain, pre-set elevations. A diagram of the slide gate is shown in Figure 3. The slide gate's default position is up, with the gate completely clear of the water to maximize the area of the opening so that the gate does not influence flows through the culvert. A generator-driven screw assembly closes the gate when river elevation exceeds the pre-defined threshold (Stebbings, 2016). The slide gate assembly is owned and maintained by the Port of Tacoma.

The metal slide (sluice) gate has a 5-foot by 5-foot flap gate inset into the front (Port of Tacoma, 1997b). This flap gate is designed to allow water to flow from Clear Creek to the Puyallup River when there is a head difference and the slide gate is lowered, allowing for greater drainage. Head is defined as the difference in elevation between two points in a body of water – in this case between the water in the culvert draining from Clear Creek and the water in the Puyallup River. However, according to Port of Tacoma staff, when the slide gate is fully lowered, the flap gate latches shut and cannot open (Myers, 2017b).

In late December 2016 or early January 2017, ice buildup jammed the slide gate during regular operations, causing the motor to burn out and damaging a gear in the gate assembly. Due to difficulties in obtaining replacement parts, the slide remained stuck partially open until May 11, 2017, when it was repaired. According to Port of Tacoma staff, they were unaware how far open the gate was from the time it was stuck until late April 2017 (Myers, 2017a). At that time the Port of Tacoma manually raised the slide gate to allow for better drainage and fish passage (Myers, 2017b). The gate is now functioning normally.

This action would modify the slide gate's set point to lower and raise the gate at higher river elevations. This is likely the simplest step that can be taken to improve both drainage and fish passage through the culvert. The current settings for the slide gate assembly cause it to lower while Clear Creek is still draining to the Puyallup River. The frequency of operation (once or twice daily) also contributes to unnecessary wear and tear on the slide gate assembly's mechanical components.

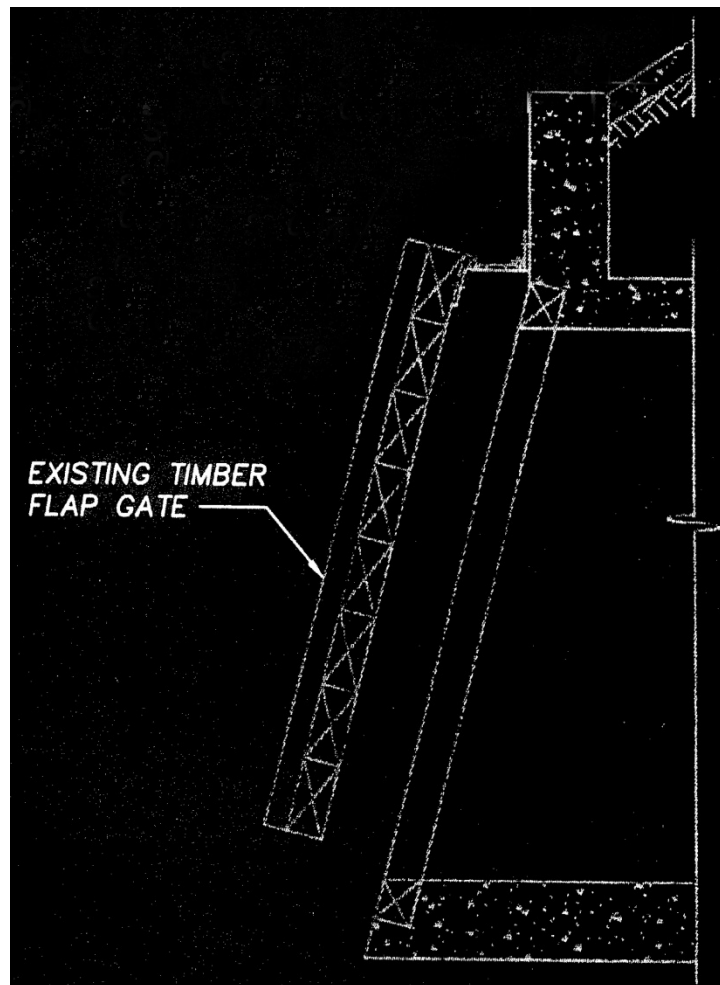
Figure 4 Wooden Flap Gate Schematic

The wooden flap gate (on the right in Figure 2) is a simple balance system that opens and closes based on head differences between the river and Clear Creek. A diagram of the wooden flap gate is shown in Figure 4. The gate is hinged at the top, and water pressure from the river pushes the gate closed when water levels in the river exceed water levels in Clear Creek. Then, when water levels in Clear Creek exceed water levels in the river, water pressure from Clear Creek pushes the gate open. The angled position of the gate increases the amount of force required to open it, so there will be some minimum head difference required to push the gate open. The greater the head difference, the faster the outflow and the more the gate will open. When there are small differences in water levels, the gate opens only slightly, resulting in small outflow rates and little to no opportunity for fish passage. Since this type of gate remains in the water at all times, flow through this barrel of the culvert is never entirely unobstructed.

Wooden Flap Gate Schematic showing angled gate and frame.

Given the current condition of the wooden flap gate, there is also a strong possibility of leakage when the gate is closed, which cannot be accounted for with the data available. The amount and potential importance of leakage could be assessed by physical examination of the flap gate at low water. This would include measuring the size of any gaps between the gate and its frame and holes in the surface and by observing the flow back through the culvert when both gates are in the closed position. With the gates closed, flow in either direction would be caused by leakage around or through the gates. This leakage is expected to be relatively trivial in relation to Clear Creek or Puyallup River flows and is not expected to contribute significantly to observed water levels in the Clear Creek area.

Recommendation #6: Pursue replacing the wooden flap gate as a long-term option if the tide gates will not be removed

Replacement of the wooden flap gate with a new, fish-friendly flap gate would improve drainage, fish passage, and the reliability of flood protection. However, the action would be expensive and the permitting and construction needs would be substantial. Therefore, this action is unlikely to be cost effective if the tide gate would be removed in the future as part of the Clear Creek Floodplain Reconnection Project. If that project is not pursued in the future, or if the project plans change and no longer include removal of the tide gates, this action should be considered as a long-term option to improve operation of the tide gates.

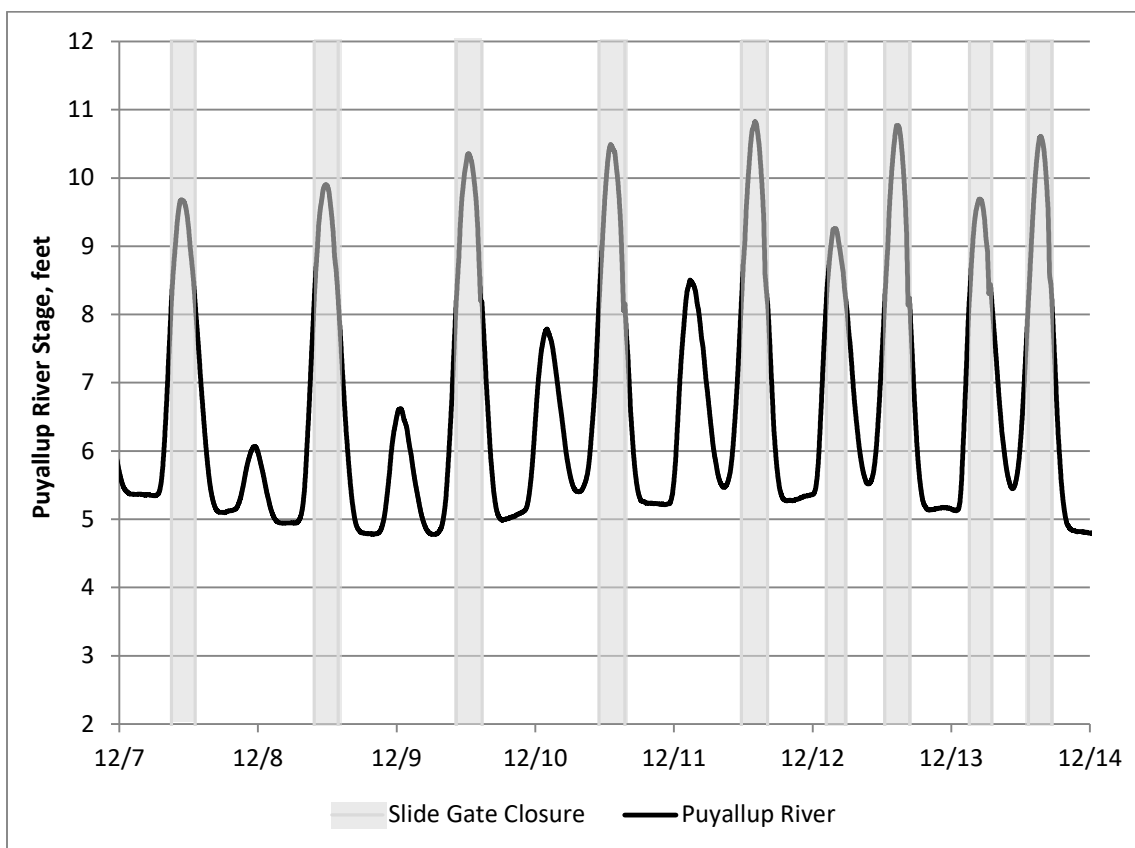
Figure 6 Slide Gate Operations

ESA analyzed four months of rainy season gage data, a representative sample of which is shown in Figures 6 and 7, below. Rapid changes in the readings of the pressure gage attached to the gate indicate the times when the slide gate was raised or lowered. Cross referencing those times with the water levels in the Puyallup River, it appears that the set point for the slide gate to be raised or lowered is approximately river elevation 8.2 feet NAVD 88. Figure 6 shows one week of water level data from the Puyallup River gage, shown as a black line, superimposed over the periods of tide gate closure, shown as gray bars. During this time period, variations in tidal elevations due to the normal tidal cycle caused the slide gate to shift from closing once per day (12/7 to 12/11) to closing twice per day (12/12 to 12/13).

Water levels recorded in the Puyallup River at the Clear Creek tide gates are shown by the black line. Periods of time when the slide gate was closed due to high water are indicated by the shaded bars.

Design documents from the Port of Tacoma indicate that the slide gate was not originally intended to be lowered daily (Port of Tacoma, 1995a). These documents indicate that the gate should close during the 2-year instantaneous peak flow, but not during the annual maximum daily-average flow, even if concurrent with a high tide. Consequently, if operating as originally envisioned, the slide gate should be lowered less than once per year. The preferred closing and opening elevations listed in the design report are when the river reaches 12.5 and 12.0 feet NAVD 88, respectively – significantly higher than the observed lowering of the slide gate at elevation 8.2

feet NAVD 88 (Port of Tacoma, 1995a). Design documents correlate the preferred gate closure trigger elevations to Puyallup River flows of approximately 16,000 cubic feet per second (cfs) (Port of Tacoma, 1995b). However, during the December 7 through December 14, 2016 period shown in Figure 6, Puyallup River flows were only 2,140 cfs to 3,040 cfs as measured at the USGS gauge at Puyallup, 3.7 miles upstream of the Clear Creek confluence. Puyallup River flows did not reach 16,000 cfs during winter 2016 – 2017, although they came close (15,200 cfs) in early February and again (15,600 cfs) in mid-March (USGS, 2017). If the slide gate was operating as originally envisioned, it would have lowered no more than twice, if at all, in the past year, as opposed to once or twice per day as observed.

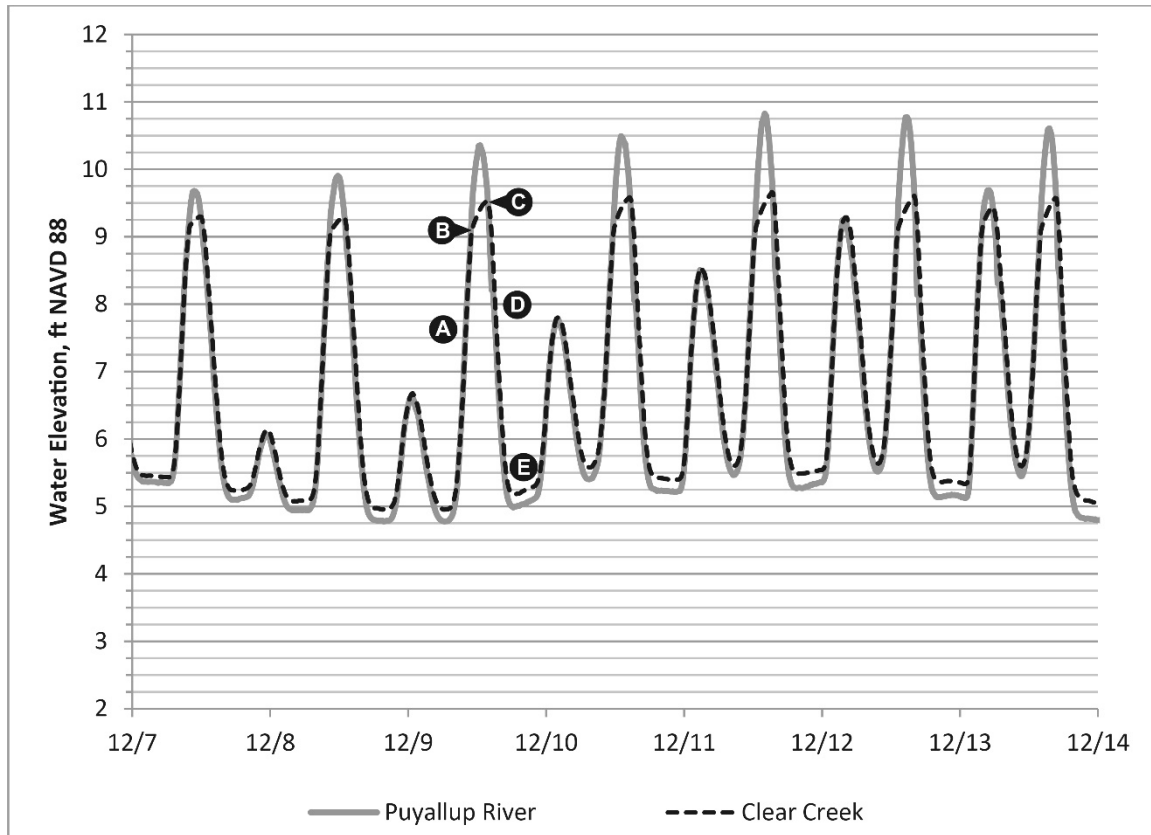
Figure 7 Water Levels in Clear Creek and Puyallup River

Water Levels in Clear Creek and the Puyallup River over a representative one week period.

Figure 7 shows the effects of the tide gates on water levels in Clear Creek. The solid line shows Puyallup River water elevation and the dashed line shows the Clear Creek water elevation. Water levels in Clear Creek and the Puyallup River rise in synchrony (A) with the rising tide until both gates close (B), blocking peak high tide from entering Clear Creek. After both gates close, Clear Creek can no longer drain, so water levels on the Clear Creek side of the gates slowly rise. The flap gate opens when the rising water level in the stream matches the elevation of the falling limb of the tide in the river (C). The slide gate opens at its preset point. Water levels then fall in synchrony (D) until a control on the base water elevation of Clear Creek prevents water levels in Clear Creek from falling further, creating a difference between the stream and river levels (E) at low tide.

The magnitude of this low tide difference ranged from less than 0.01 feet to approximately 0.75 feet during the monitoring period, with the larger differences correlated to lower stages in both Clear Creek and the Puyallup River. Given the distance between the two gates, the difference is most likely caused by the slope of the channel and differences in base water surface elevation when not backwatered by the tide. Other explanations for the difference could include:

- The inlet of the culvert or some other obstruction could be acting as a barrier at low flows.
- Debris accumulation on the trash rack may be impacting drainage.
- There may be a small survey error in the measured gage elevations.

The explanation for the difference could be resolved by surveying the area to derive accurate distance and elevation relationships or by observation of the culvert at low water.
