FINAL DRAINAGE INVENTORY MEMORANDUM

Farming in the Floodplain Project

Prepared for
PCC Farmland Trust

May 2017

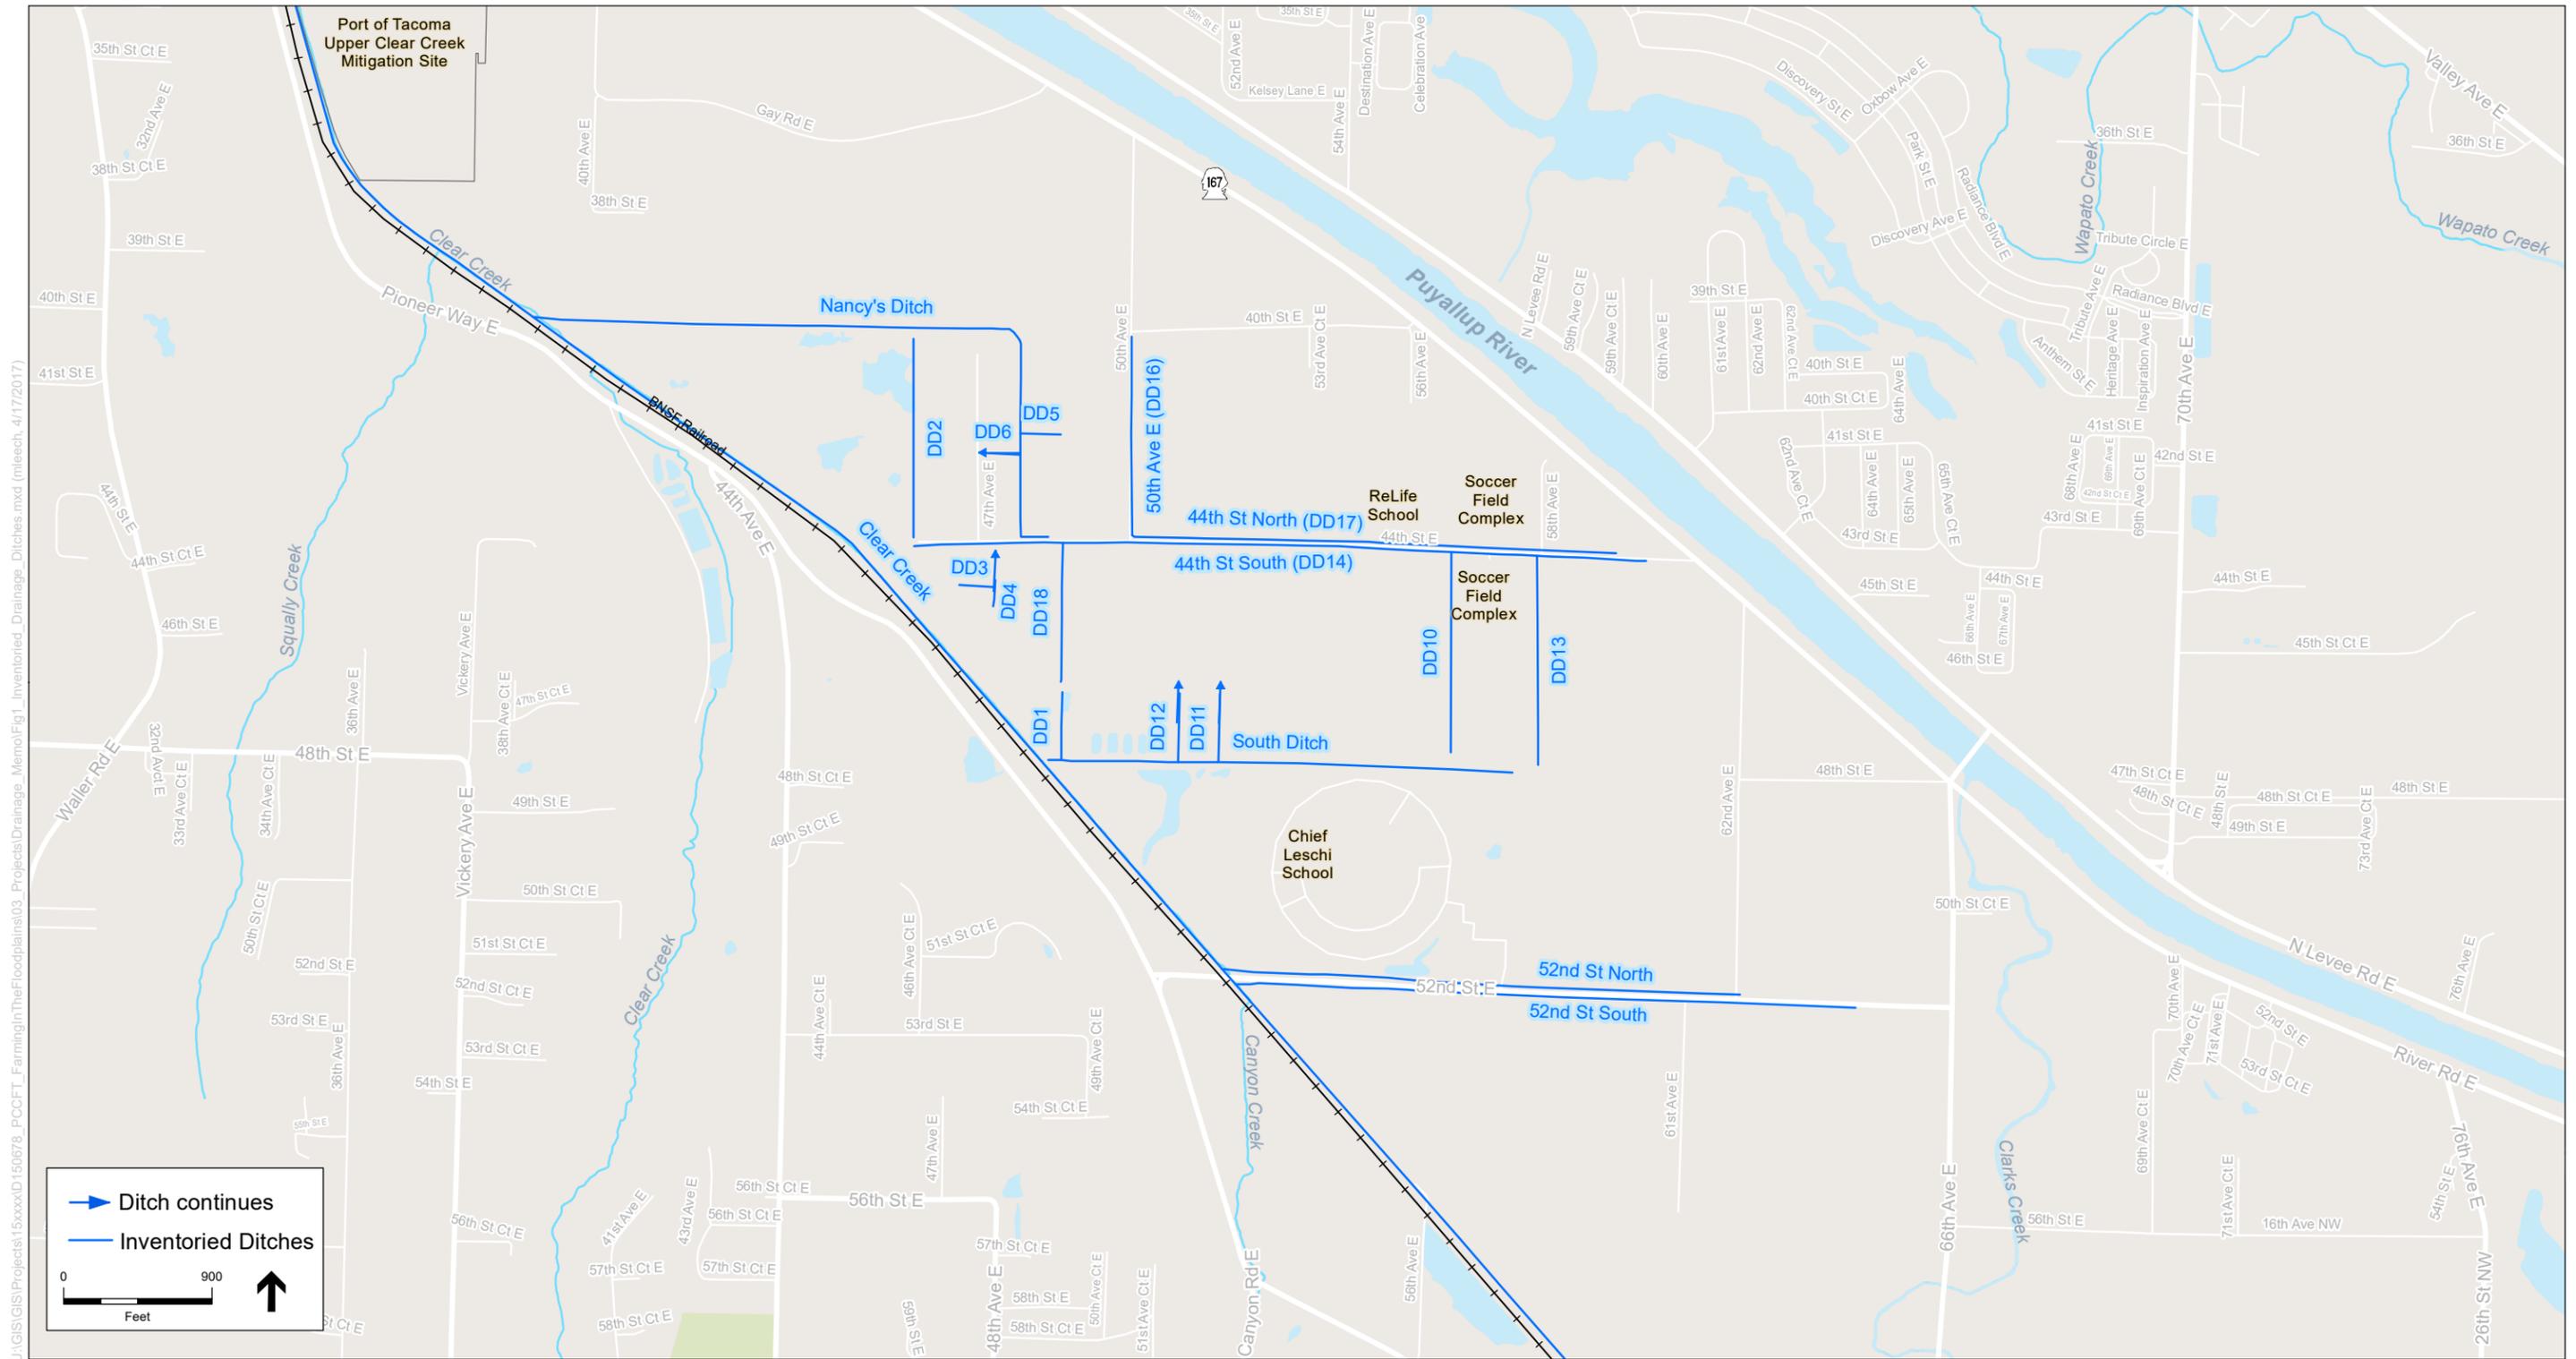
Figure 3
Inventoried Drainage Ditches

Field investigation for the agricultural drainage inventory took place September 20 through 24, September 27, October 12, 2016, and January 19, 2017. Observations from the field investigation are presented below by drainage ditch. Figure 3 shows the drainage ditches inventoried during the field investigation. Figure 4 shows the drainage ditches inventoried with flow direction arrows where flow direction is known. Figures 5a and 5b show the locations of inventoried culverts. The figures only show drainage features inventoried during the field work. They do not show other drainage features that ESA was informed about or those we observed in the field, but were not able to inventory (such as the roadside drainage ditch on the west side of 50th Avenue). The figures only show connections that were directly observed. Where one end of a ditch was inventoried but the end point of the ditch was not observed, the figures show an arrow to indicate that the ditch continues in that direction, but that the end point was not inventoried.
