CLEAR CREEK TIDE GATE ASSESSMENT

Technical Memorandum Farming in the Floodplain Project

Prepared for
PCC Farmland Trust

July 2017

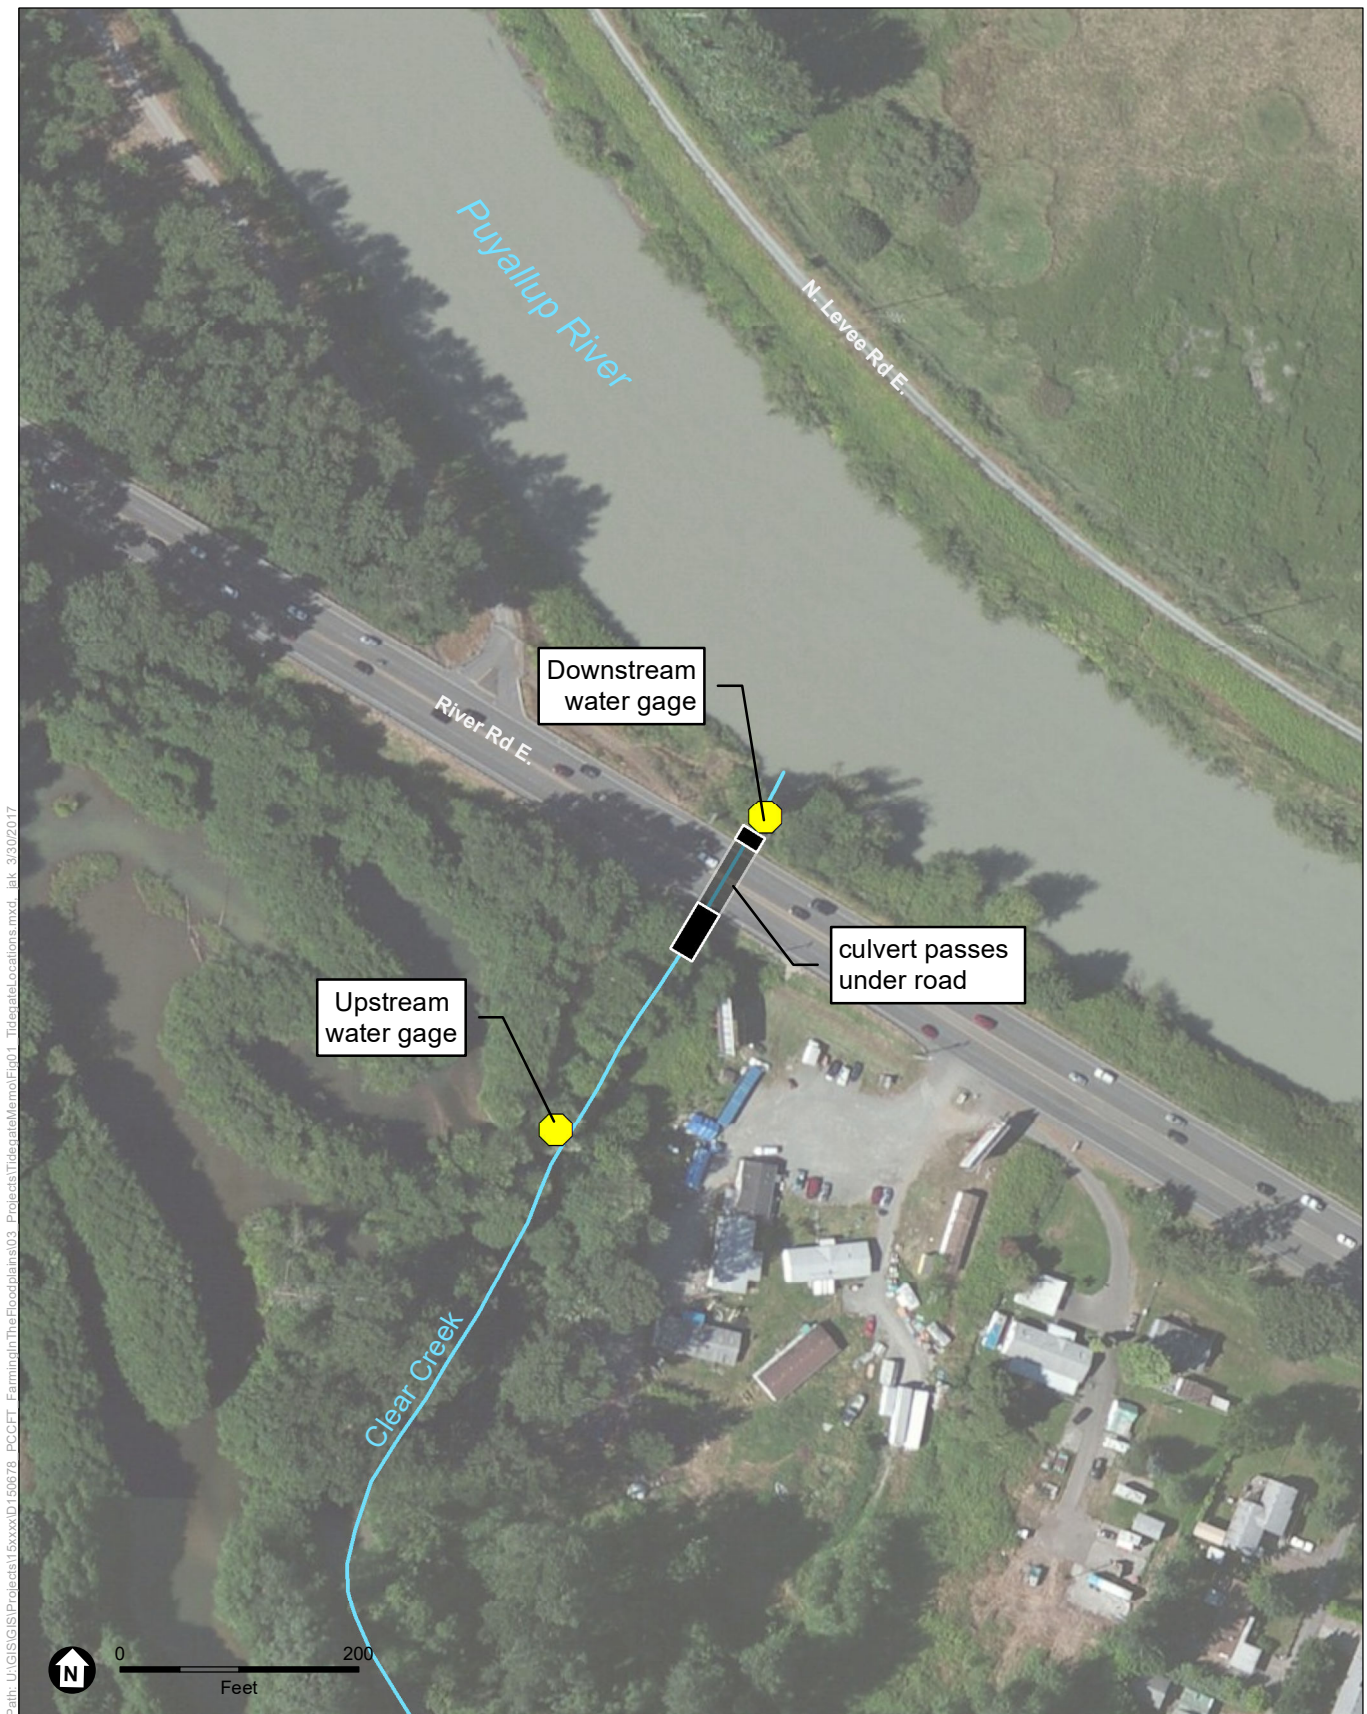
Figure 5

Pierce County staff installed several gages in the lower Clear Creek area in September 2016 to measure water levels on each side of the tide gates as shown in Figure 5. The discussion in this memorandum is based on 5 months of water level data from these gages. Pierce County installed the following gages:

- Water level gage on the Clear Creek side of River Road East, approximately 200 feet upstream of the culvert entrance (shown in the lower left in Figure 5).
- Water level gage on the Puyallup River side of River Road East, just outside of the tide gates (shown in the upper right in Figure 5).
- Uncalibrated pressure gage attached to the back of the slide gate that was used to detect gate opening and closing (not shown).
